Assessing the Decay and Integrity of Timber Structures used for Natural Flood Management on Sutherland Beck, Pickering, North Yorkshire

Huw Thomas & Tom Nisbet
Forest Research
April 2020

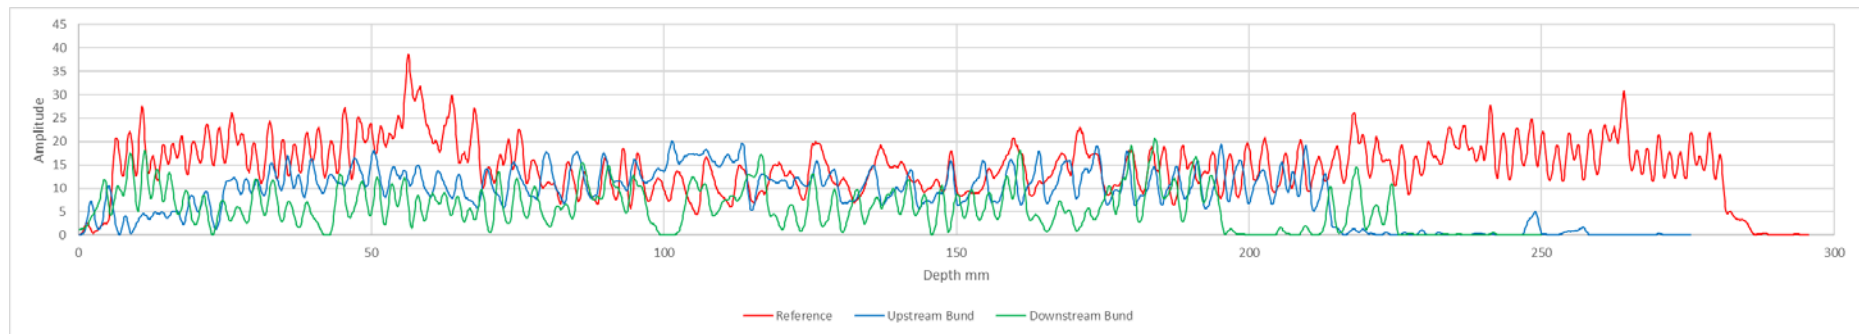
An average amplitude was calculated to obtain a reference value for the strength/condition of healthy trees. This is compared to typical amplitudes recorded for the two bunds and LWD in Figures 3a and 3b. The drill profile for the healthy trees showed consistently higher readings in the outer 7 cm depth of the circumference compared to the logs from the two timber bunds, indicating that this could be the progression of the decay front to date (Figure 3a). It is notable that the state of decay appeared to be worse on one side of the log compared to the other, with one side showing almost complete decay. Another observation was that the lower bund generally displayed lower readings compared to the upper bund, suggesting that the rate of decay was greater here. Decay appeared to be progressing throughout the width of the log from the lower bund, with pockets of complete decay close to the centre of the log (e.g. at 10 cm depth).

Figure 3a Typical drill profiles of the reference drill sample and the upstream and downstream timber flood storage bunds

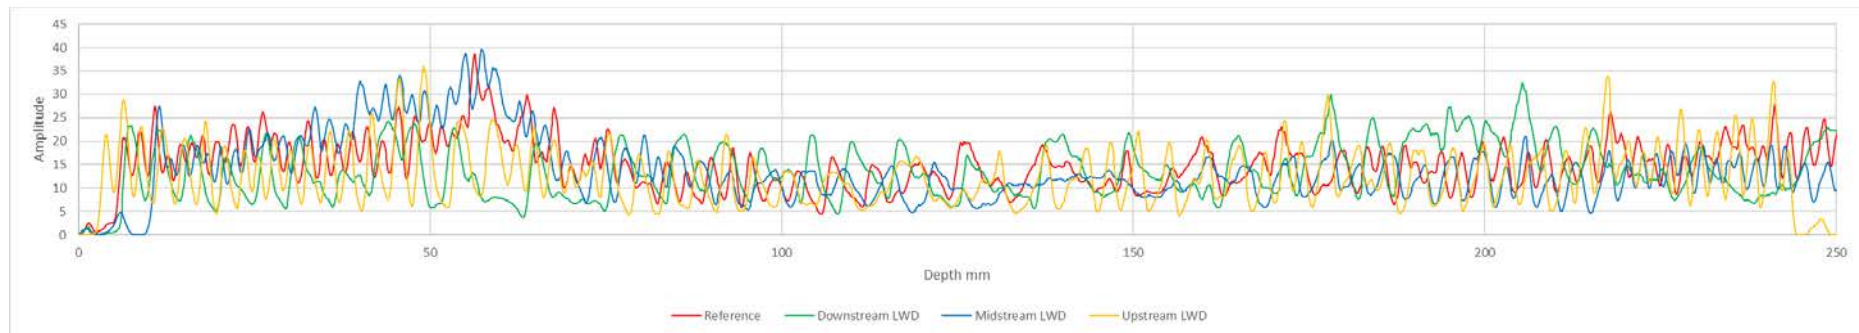
In contrast, the traces for the selected logs from the three LWD generally overlapped with those of the healthy trees, indicating little decay to date (Figure 3b). This accorded with the relatively young age of the structures, which were only installed in 2019. Aside from the outer 10 mm of the circumference, nearly all values for the three LWD were >5 .

Figure 3b Typical drill profiles of the reference drill sample and in-stream LWD

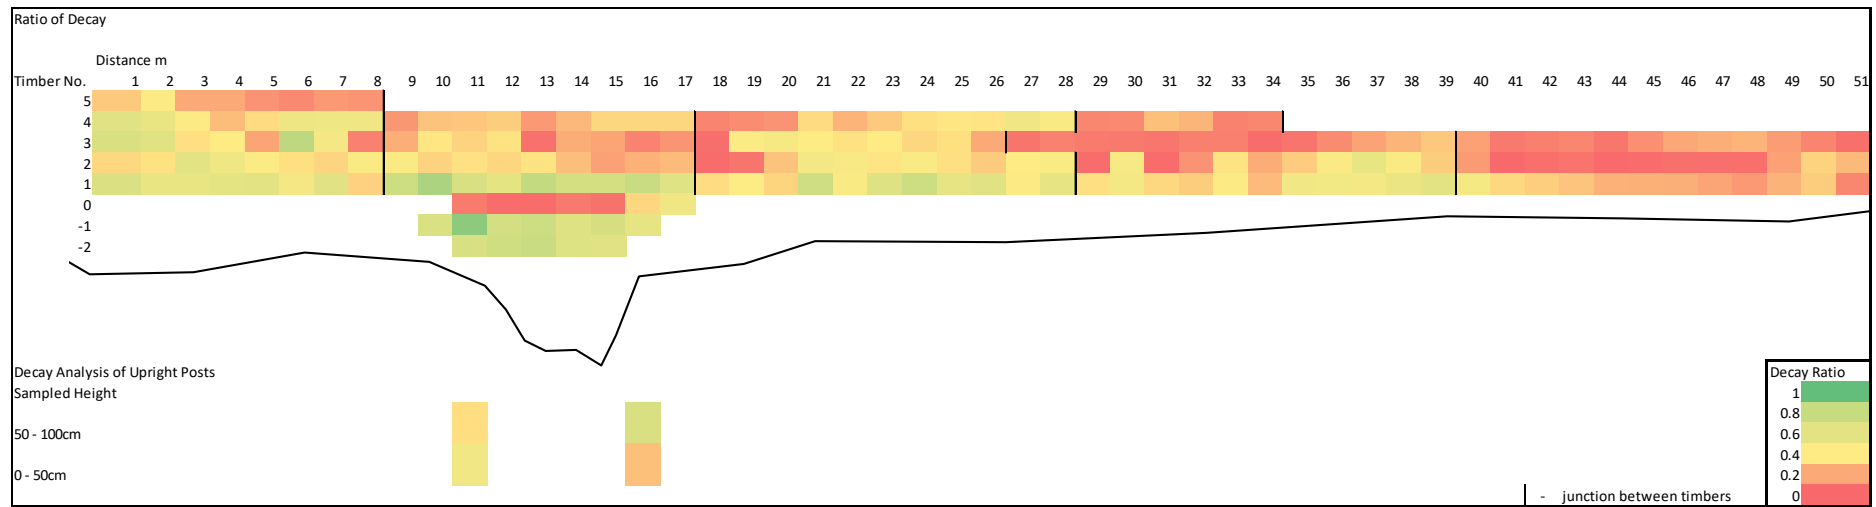
Figure 4 shows the relative condition of each log in the bund based on the ratio of the average amplitude to that of healthy standing trees. Using the selected threshold ratio of 0.4 for an acceptable level of decay, around half of the logs had more than 50% of their length below this value. The extent and level of decay was generally greatest in the top timbers and towards the northern side of the structure (right bank). This is likely to be due to the open ground on the right bank, leaving the structure more exposed to the weather and to wetting and drying. The southern side is sheltered by the steep valley side, being north facing and partly sheltered by the remaining standing trees and shrubs. Figure 5 displays an image looking across the structure to the south.

Figure 4 Diagram showing drill readings for the lower timber flood storage bund, expressed as the ratio of decay versus reference live trees. Measurements are displayed for the individual one-metre subsections of each log, with the number of stacked logs varying across the structure (black vertical lines demarcate junctions between each log stack). The surveyed cross section of the site is shown for orientation, with the negative timber numbers corresponding to those logs that extend below ground level into the river channel. Ratios are also displayed (below the cross section) for the two upright posts supporting the timber bund on either side of the river channel.

Of the measured structures, the condition of the downstream flood storage bund is the main cause for concern, having been considerably weakened by decay. Around half of the logs in the structure have more than 50% of their length below the assumed 0.4 critical threshold, while the two central supporting posts are also significantly decayed. It is questionable whether the structure would now support a major flood event and in view of the extensive nature of the decay, probably past the stage of maintenance.

Consideration therefore needs to be given to its replacement if there is a desire to maintain its original contribution to catchment flood storage. However, it is important to note that the volume of flood storage provided by the downstream bund is relatively small ($\sim 1,260 \text{ m}^3$) compared to the upstream bund ($\sim 3,620 \text{ m}^3$) and thus less significant. There is a strong case for leaving it as it is to gain greater knowledge of how the bund continues to degrade, at what point it breaks and how far the released timbers move. The within channel part of the structure and lower timbers across the bund are also in a better condition and thus will continue to offer some flood storage and a slowing effect.

On balance, it is recommended that the downstream bund is left to degrade naturally and continued to be monitored to improve understanding of its operation and lifespan, including to help test the 0.4 critical threshold. The main intervention would be to consider replacing timber 0 at ground level in the channel, which is significantly decayed. A decision about whether to replace the entire structure should await its final collapse. An alternative option would be to plant and try to establish closely spaced willow or alder trees along the line of the timber bund to create a more "living" and supporting structure that might extend the lifespan of the bund.

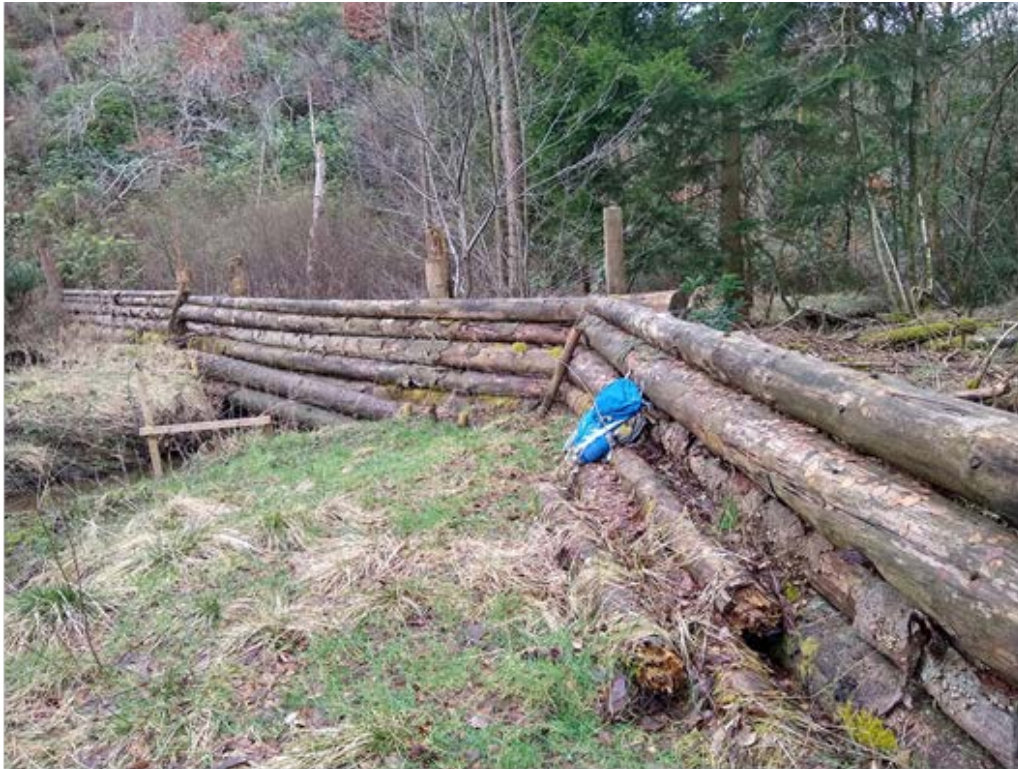
Figure 5 Photograph showing the downstream bund looking to the south/left side of the structure as represented in Figure 4.

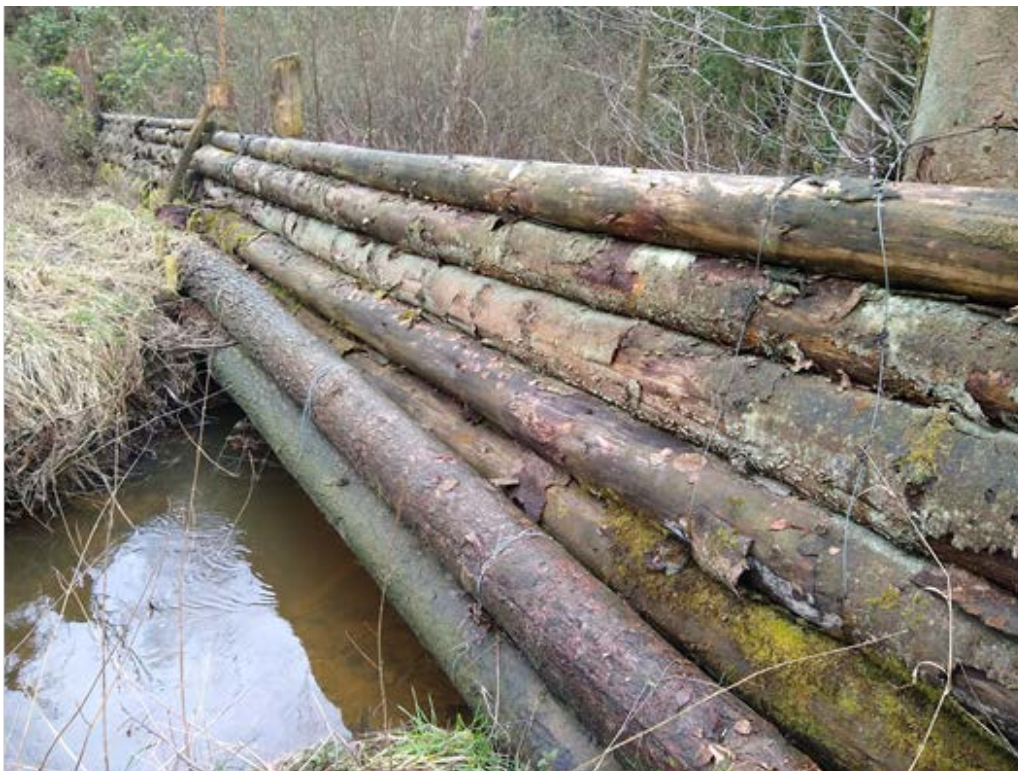
The top timber within the channel (Timber No. 0) is unusual in showing evidence of significant decay compared to those below and immediately above, which appeared to be sound (Figure 3a). However, the bottom two logs were replaced in 2019 after scouring of the south bank led to these timbers becoming loose and dropping down at the outside edge, causing more scouring. The decay was greatest at one end of the log and could have spread out from where it abuts the riverbank. Figure 6 shows the generally poor condition of the fifth log from the top, with moss extending across its surface from both banks.

Figure 6 Image showing the timbers spanning the river channel on the lower bund, with the most decayed log covered by moss (fifth timber down from the top). The two bottom timbers (numbers -1 and -2 in Figure 4) were replaced in 2019 and therefore much less degraded.

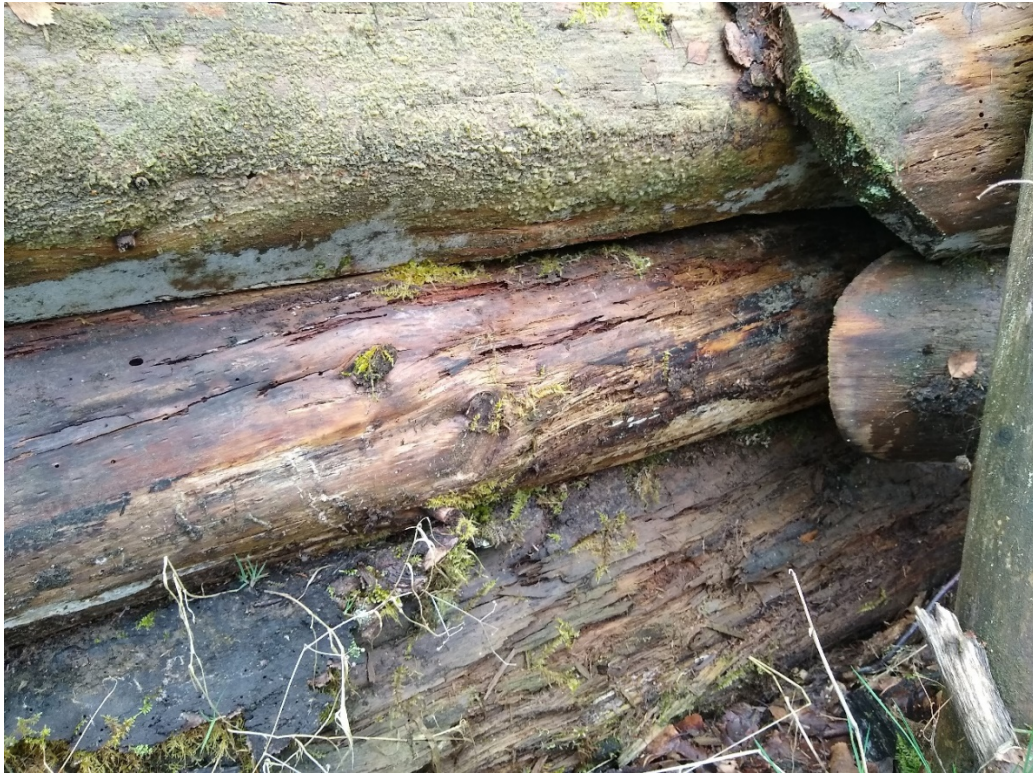
The condition of the two supporting posts at 11 m and 16 m distance, on either side of the river channel, were also tested and showed significant areas of decay, with readings near or below the 0.4 threshold (Figure 3a). There is also a related issue with the degree of decay in the end logs at the junctions of the structure, possibly linked to supporting posts, wedges and wiring, or simply decay progressing from the exposed ends. In particular, there was a significant level of decay in the end logs at the junction between 17 and 18 m, where the depth and force of flood waters is likely to be greatest during high flows, placing additional strain on an already weakened part of the structure. Figure 7 shows a close-up of the decayed timbers at this junction.

Figure 7 Close up image of decayed timber at the 18 m junction on the downstream flood storage bund.

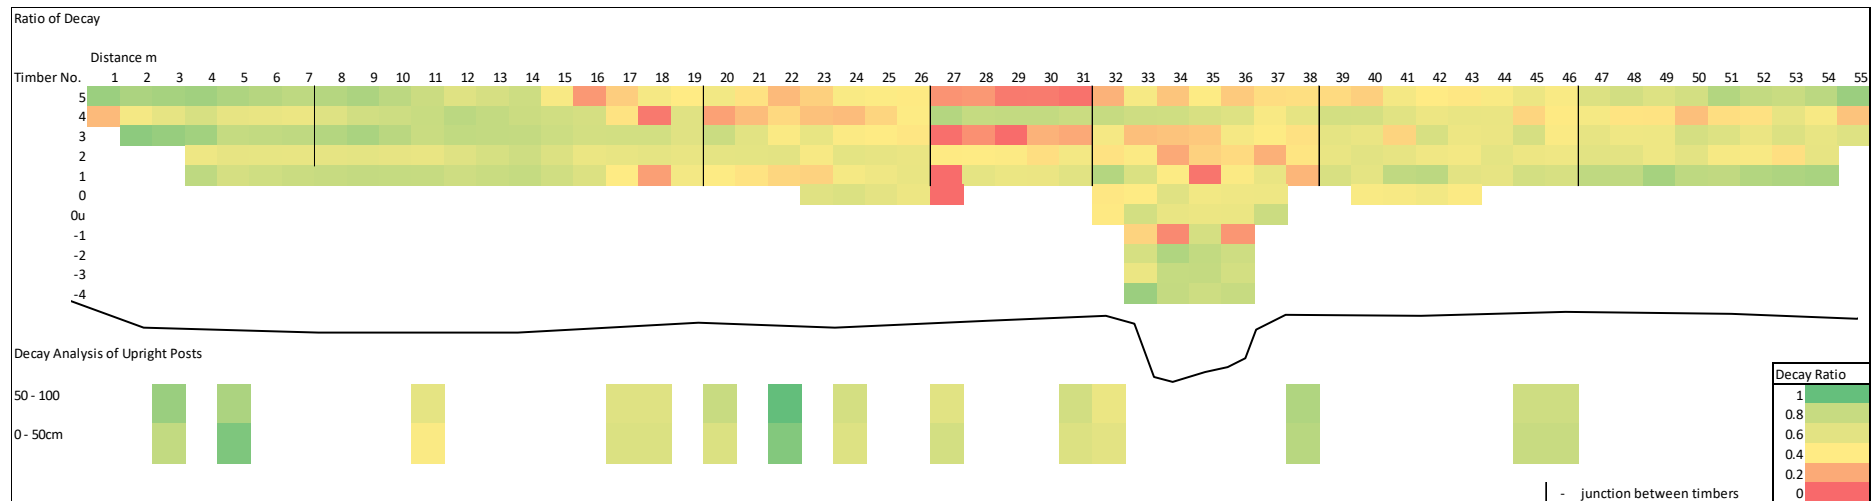
Overall, the upstream bund was in a much better condition than the lower one, with only four of the 42 logs having more than 50% of their length at below the 0.4 decay threshold (Figure 8). This is likely to be due to the more sheltered nature of the bund, which lies below a closed canopy of mature conifer trees. The bund was originally constructed using trees from thinning the overhead stand. The end sections of the bund were the least decayed and the centre one the most, which lies to the side of the river channel, perhaps reflecting the additional shelter provided by the adjacent steep slopes. However, there was significant variation in condition between the five logs in the central section, with two very decayed and an intermediate one almost unaffected. This variation is

The timber section above the river channel was the most uniformly degraded, with around 40% of the total length of above-ground logs with ratios <0.4 . In contrast, the logs at ground level and within the channel throttle were generally in a good condition. There is some evidence of greater decay in logs abutting section junctions, but the effect is inconsistent. It is most notable at 27 m (Figure 8). Top logs were once again generally more degraded than ground level ones, especially within the middle of the structure.

Analysis of the upright timbers and posts across the full length of the structure showed most of these to be sound, with ratios of decay >0.6 (Figures 8 & 9).

Figure 8 Diagram showing drill readings for the upstream timber flood storage bund, expressed as the ratio of decay versus reference live trees. Measurements are displayed for the individual one-metre subsections of each log, with the number of stacked logs varying across the structure (black vertical lines demarcate junctions between each log stack). The surveyed cross section of the site is shown for orientation, with the negative timber numbers corresponding to those logs that extend below ground level into the river channel. Ratios are also displayed (below the cross section) for the two upright posts on either side of the river channel.

The condition of the upstream timber bund is generally good and in much less need of attention. The priority is probably to replace or shore-up the central section (from 27 m to 31 m distance from the left) where the timbers are the most degraded (Figure 9). This is not urgent but recommended in the next one to two years. Depending on how quickly the level of decay progresses in the two adjoining sections, it may also be worthwhile replacing the top two logs in the 20 m to 26 m section as well as the complete above ground section from 32 m to 38 m at the same time. An alternative to replacing these timbers would be to construct an additional stack of timbers adjacent to the downstream side of these sections of the bund. It would also be wise to replace or double-up the channel timber numbered -1.

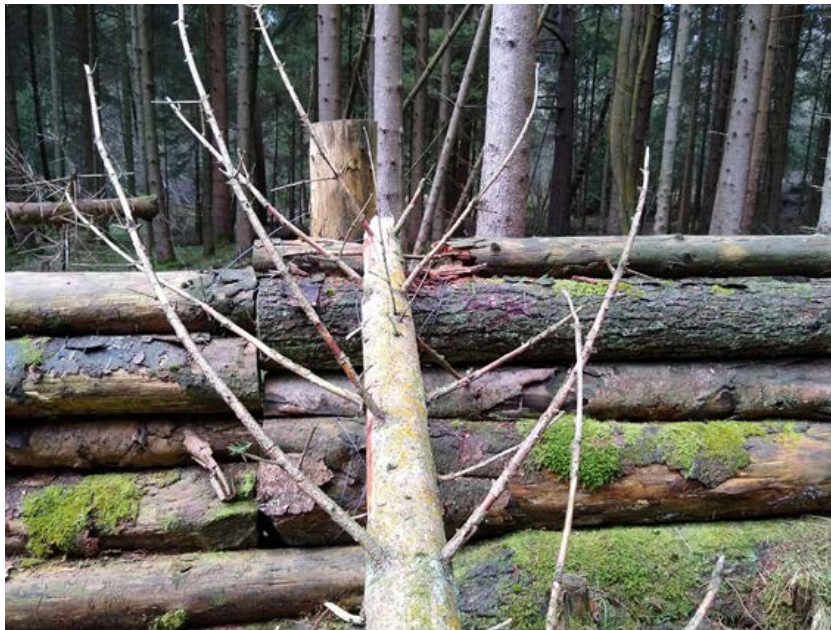
Figure 9 Image of the decaying timbers at the junction at 27m from the left edge of the upstream flood storage bund, partly damaged by the windblown tree falling onto the structure.

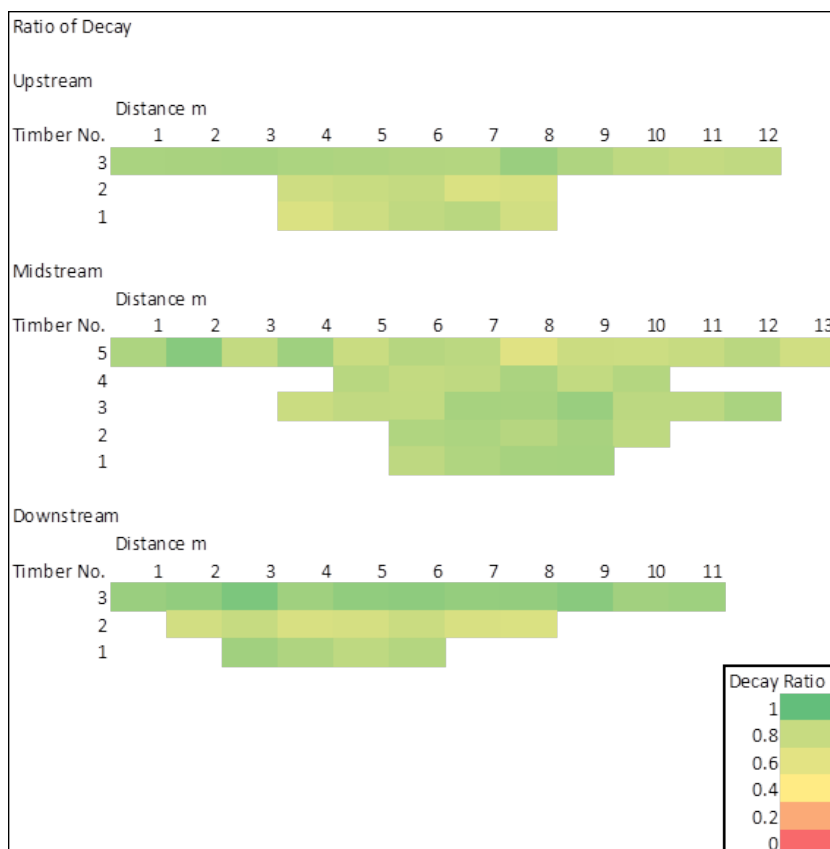
Figure 10 shows the relative condition of each log in the three LWD based on the ratio of the average amplitude to that of healthy standing trees. All were in good condition and appeared structurally sound, with most ratios >0.8 . The middle log in the downstream LWD was the most decayed but still had ratios >0.6 . A small amount of scouring was noted on the left and right bank of the channel at each dam, where the timbers had been slotted into the riverbank.

Figure 10 Diagram showing drill readings for the three in-stream LWD, expressed as the ratio of decay versus reference live trees. Measurements are displayed for the individual one-metre subsections of each log.

No significant areas of decay were found in any of the three in-stream LWD and thus no maintenance is currently required.

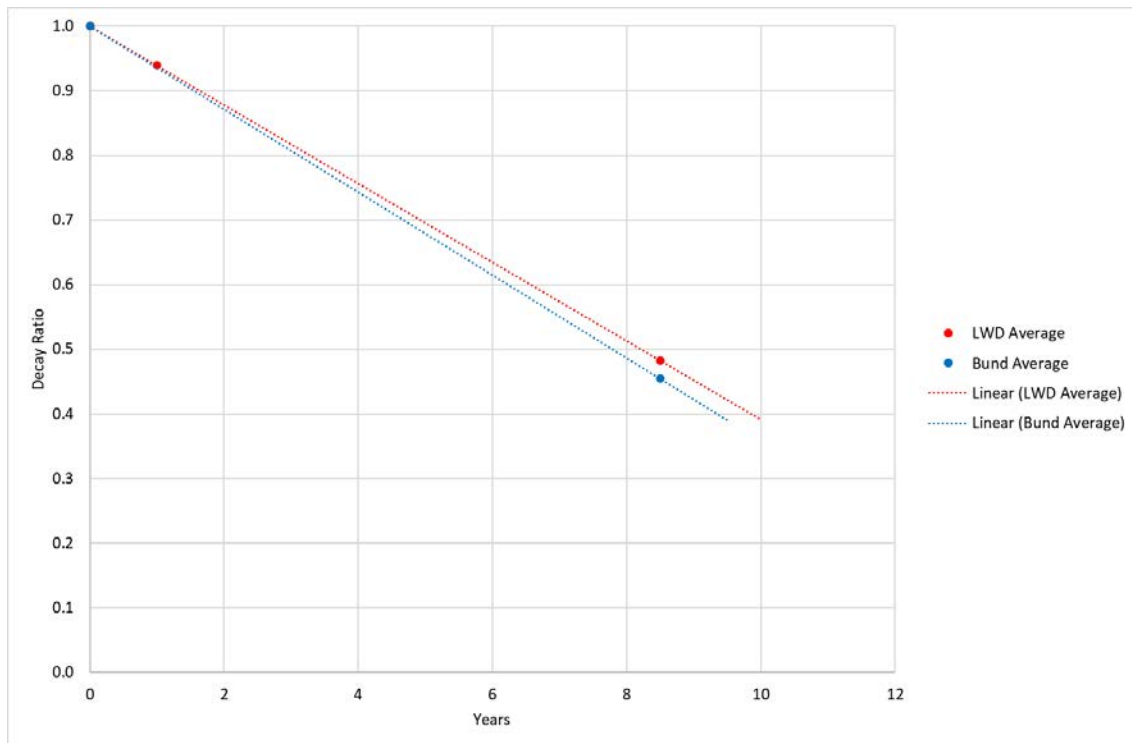
Notwithstanding these issues, it is nevertheless informative to calculate average ratios for timber structures or individual sections of these in the case of bunds to explore potential lifespans based on selected decay thresholds. Unfortunately, this study has only yielded decay measurements for two ages of structures (aged one and eight and a half years) but the resulting average ratios and an assumed linear relationship with age is plotted in Figure 11 (the value of one being based on healthy live trees; i.e. age 0). This shows the bunds to have an average ratio of 0.45, above the 0.4 threshold. Simple extrapolation suggests that they will breach the assumed critical threshold at 9.3 years. However, it must be noted that this is average ratio for the two bunds and the lower bund has already passed the critical threshold (current ratio of 0.35).

While the three measured LWD were all young structures, it is possible to separately assess the condition of the within channel timbers that are part of the two timber bunds aged eight and a half years. The combined average ratio for these is also plotted in Figure 11 and gives a value of 0.48. Extrapolating the relationship indicates that the LWD have a slightly longer lifespan than the timber bunds, reaching the 0.4 threshold at 9.9 years.

Figure 11 Relationship between recorded ratio of decay and age of timber structure (in years), with ratios based on average decay ratio values of the timber bund and the three LWD versus the average for selected healthy, live trees. Linear regression has been used to predict the lifespan of the timber structures before the average ratio reaches the critical threshold of 0.4.
