## TECHNICAL NOTE

BY COLIN J SAUNDERS AND DUNCAN IRELAND OF FOREST RESEARCH      DECEMBER 2005

The use of large-scale timber extraction machinery during harvesting places high load-bearing forces on extraction routes. Minimising this impact is particularly important on more sensitive sites. This Technical Note gives the results from two trials that assessed extraction route formations on deep peat sites. Information is provided on the evaluation of route construction materials, including straw, low impact route construction and extraction, including reducing the size of forwarder loads, and type of harvester and provision of brash.

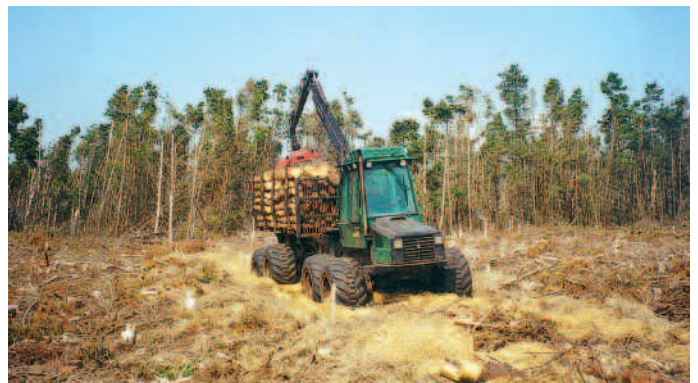
**Figure 1**

Forwarder travel on extraction route incorporating straw.

This study describes operational experience of timber extraction routes constructed from various biodegradable materials and gives a measure of their performance in supporting machine travel (Figure 1). The experience and information gathered can be applied to similar types of site.

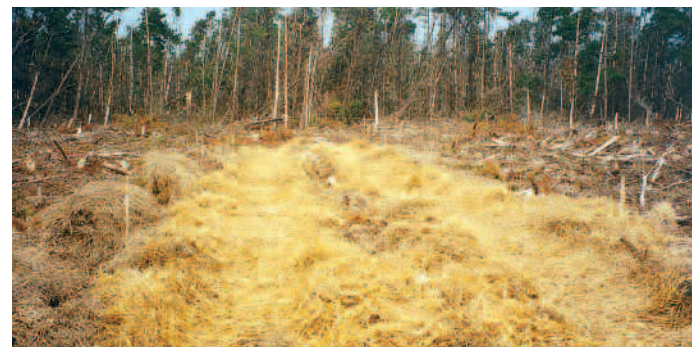
**Figure 3**

Route constructed from LP lop and top and six layers of straw after completion of the extraction trial.

- Routes that included straw in their construction withstood a large combined machine and produce weight.
- Routes that incorporated six layers of straw showed little rutting effect despite the layers of straw being compacted in places by up to around 40 cm (Figure 3).
