Appendix 14.2

Catchment Map and Photo Selection of Implemented Measures

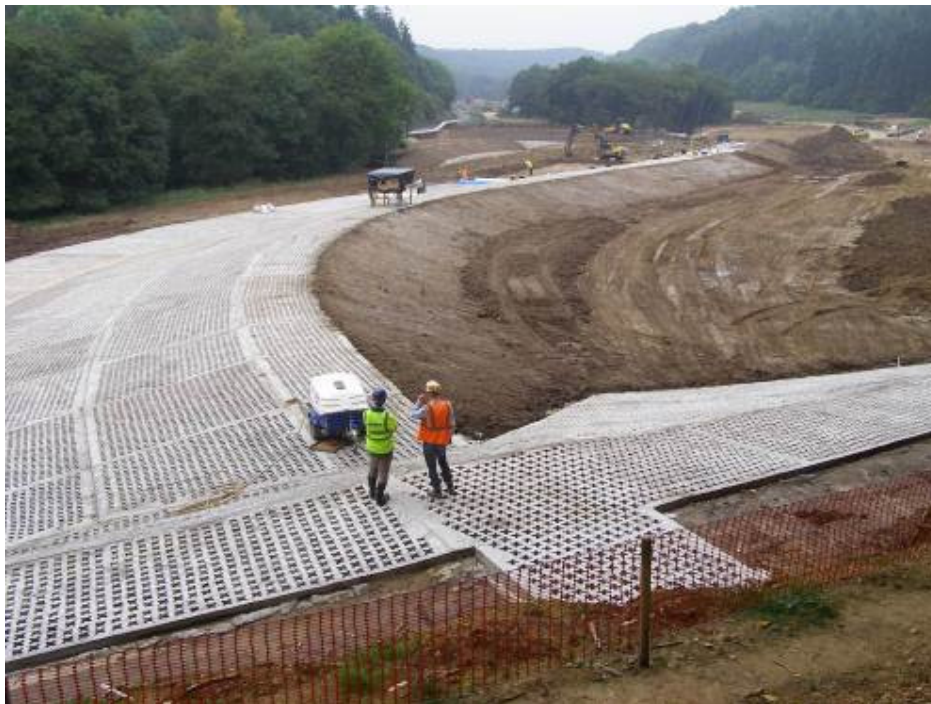
Main flood storage bund under construction in September 2014

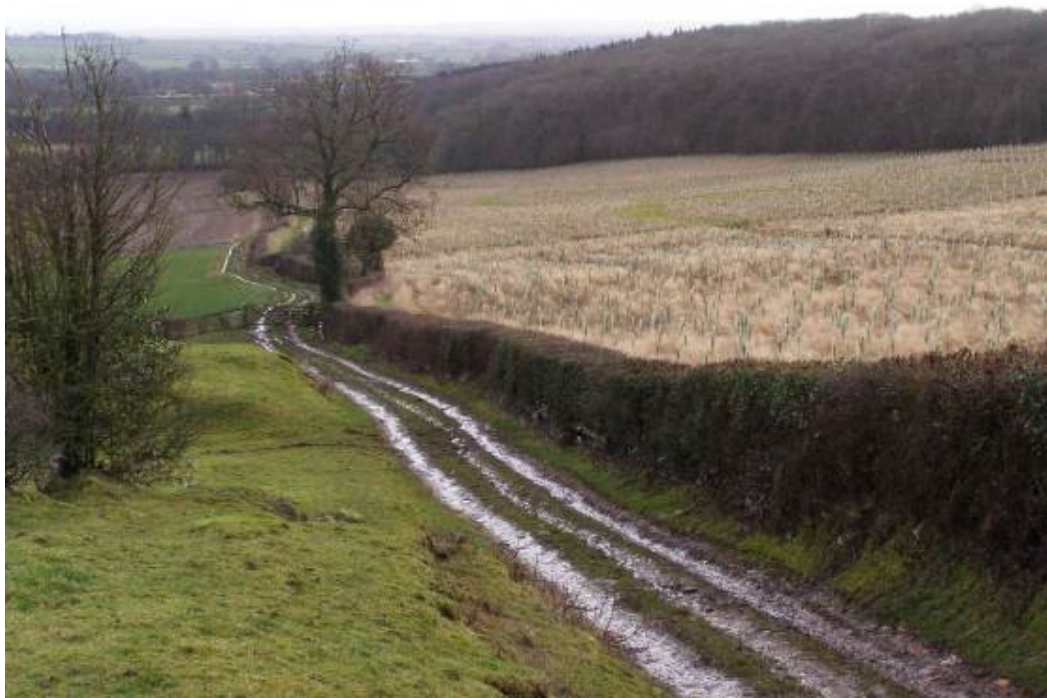
New planting of farm woodland in 2011 on sensitive soils in River Seven catchment

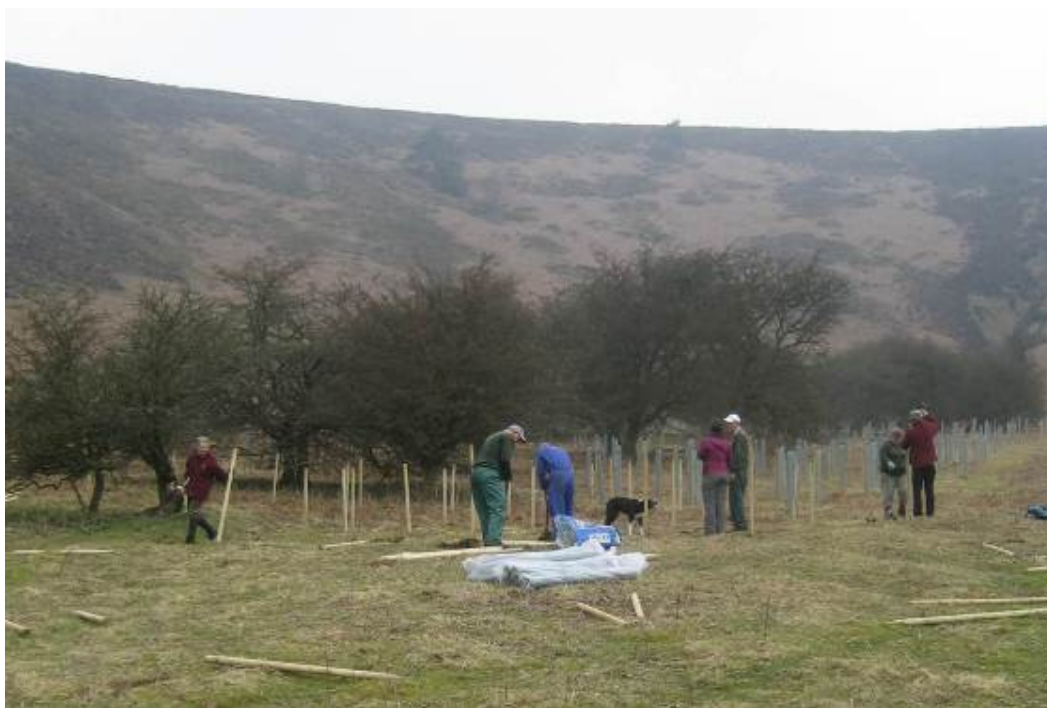
New planting of riparian woodland by volunteers in the Hole of Horcum in the Pickering Beck catchment

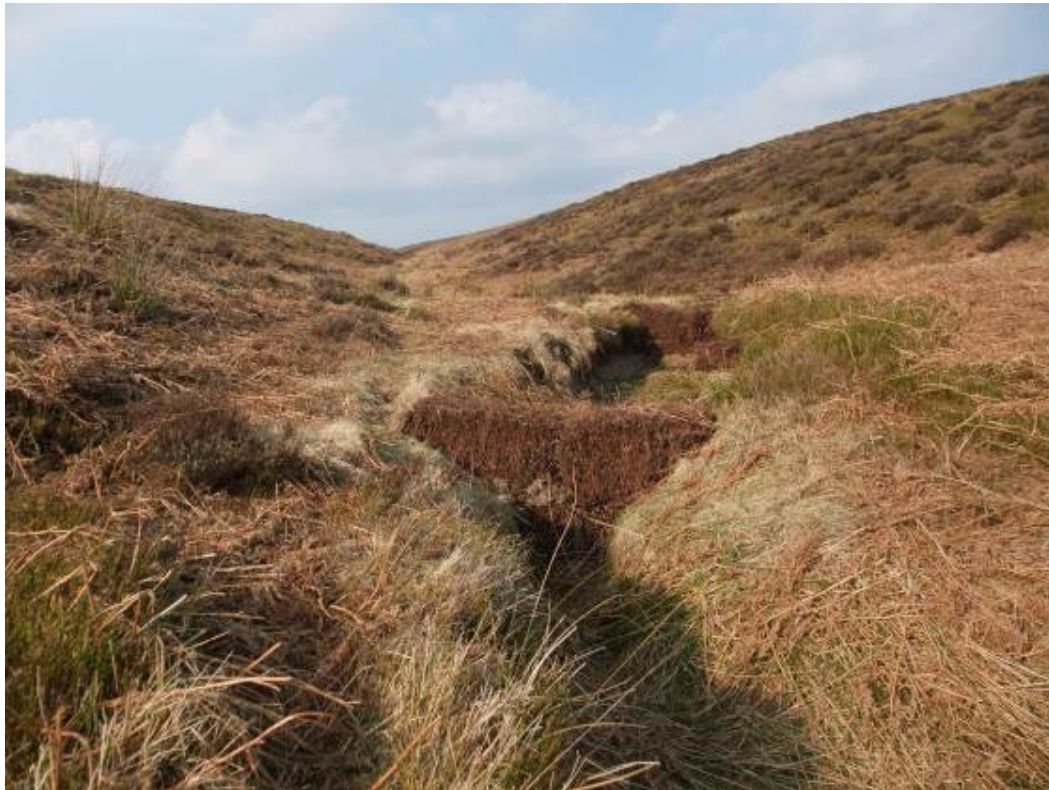
Use of heather bale check dams within moorland drains

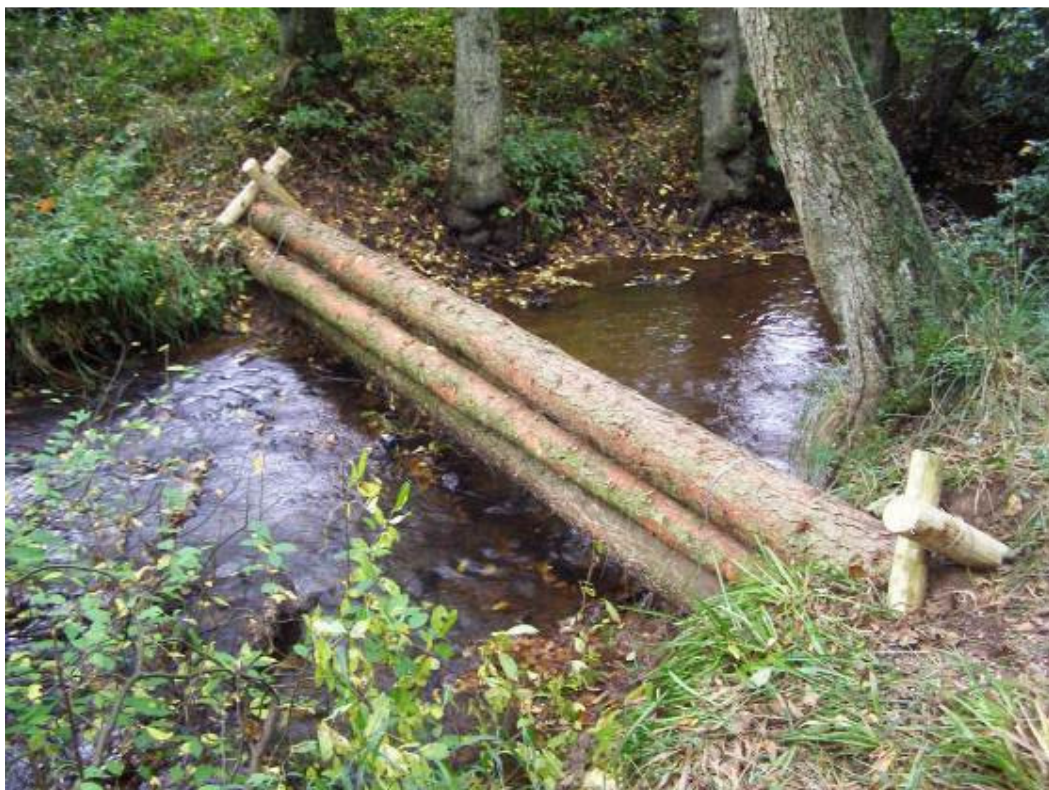
Large Woody Debris (LWD) dam secured by angled posts and wire on Pickering Beck

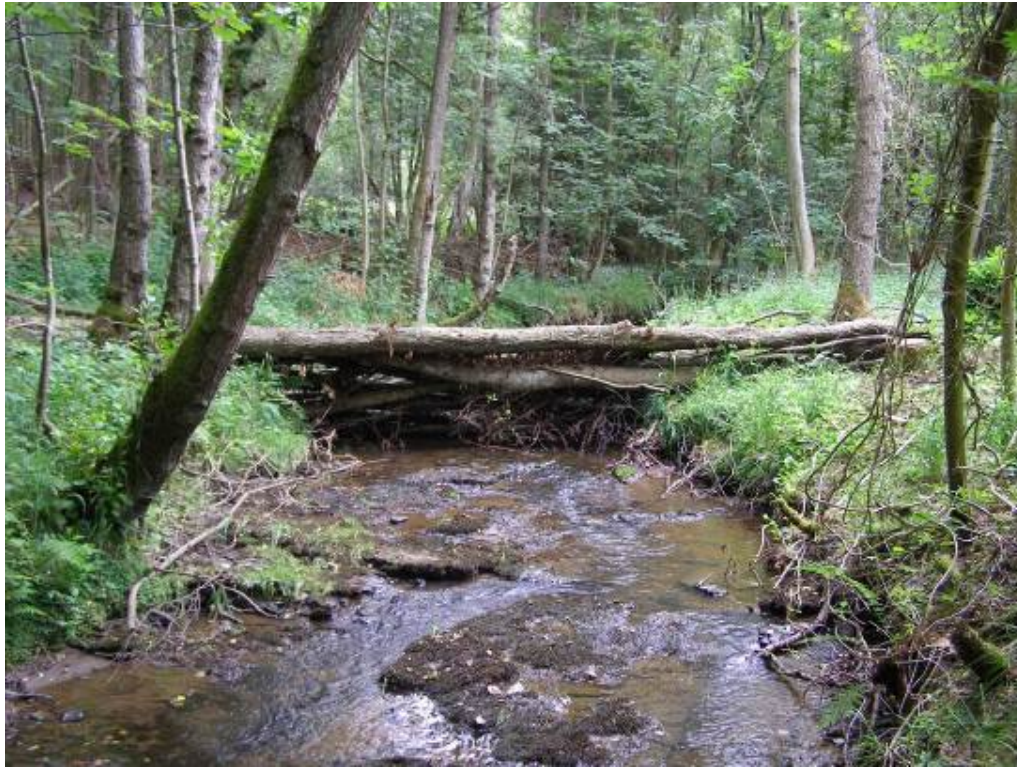
LWD dam using a cross log design on Sutherland Beck

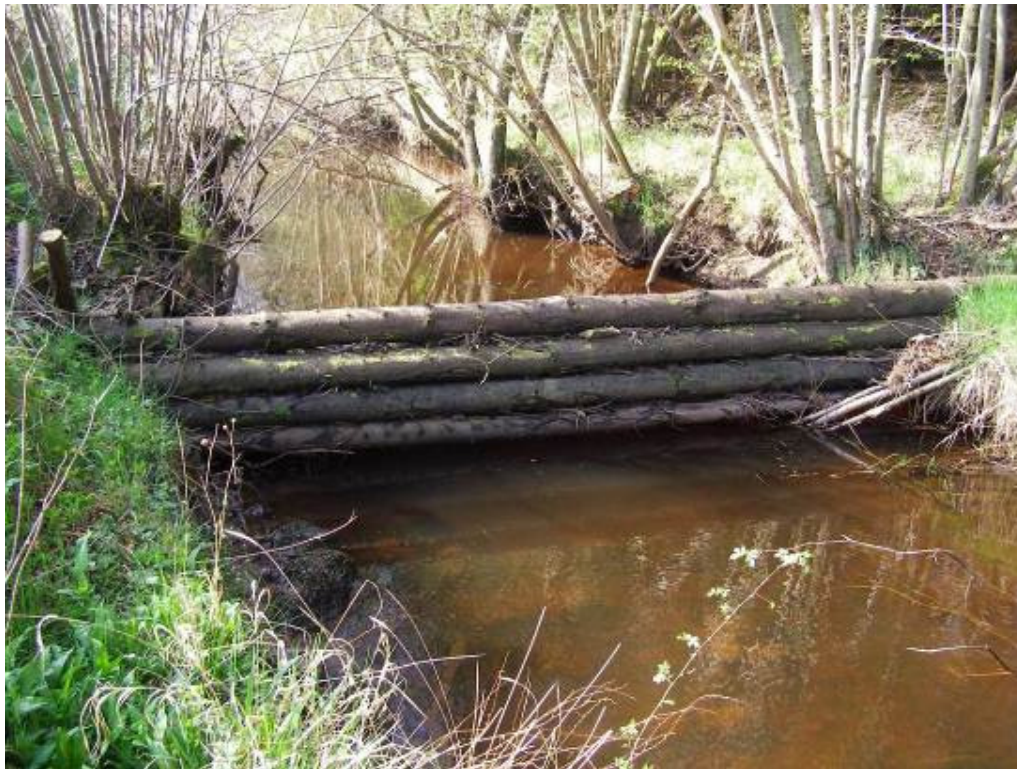
LWD dam using stacked logs secured by posts, wire and bracing on Pickering Beck

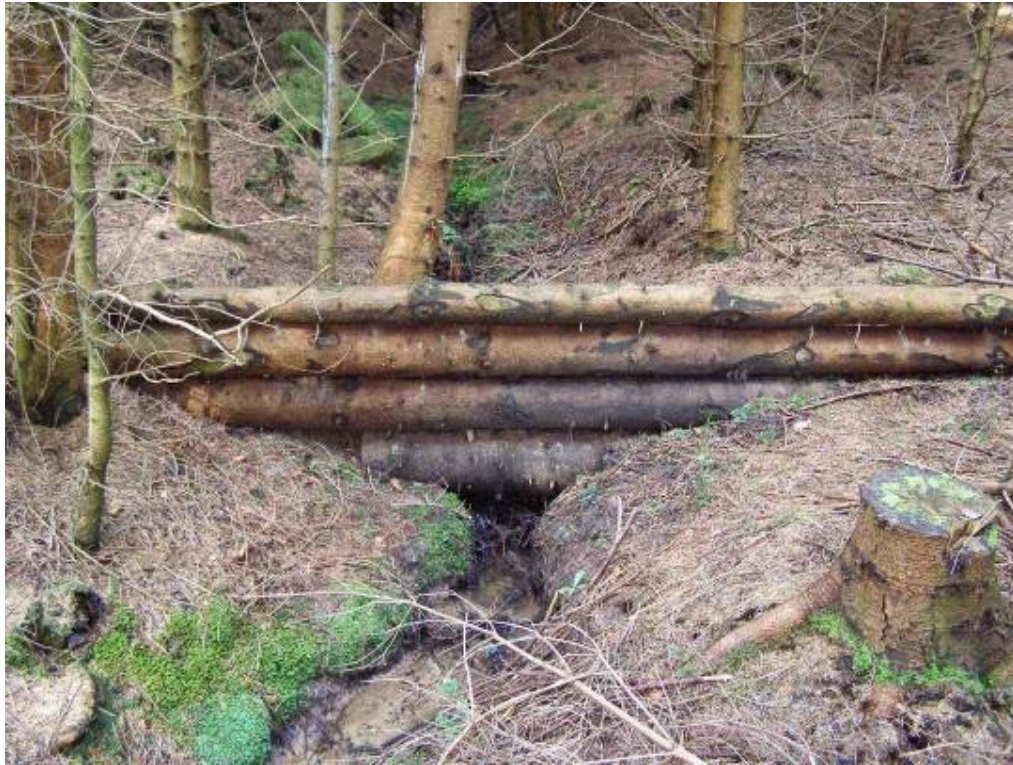
Smaller LWD dam on forest drain

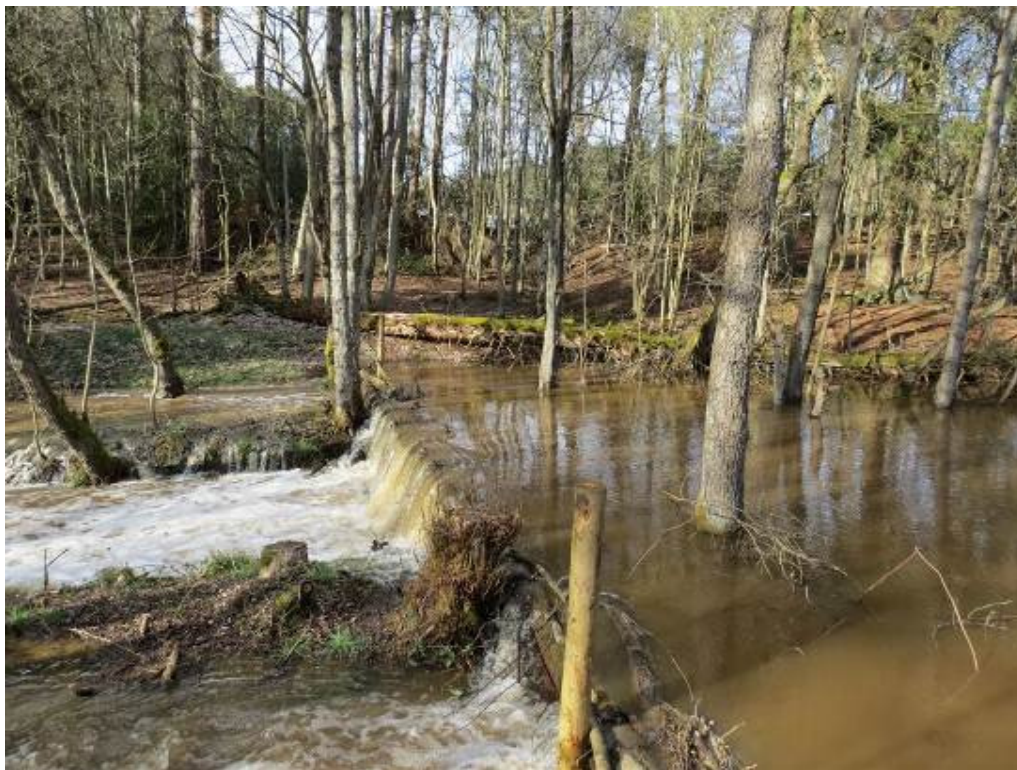
LWD dam during flood

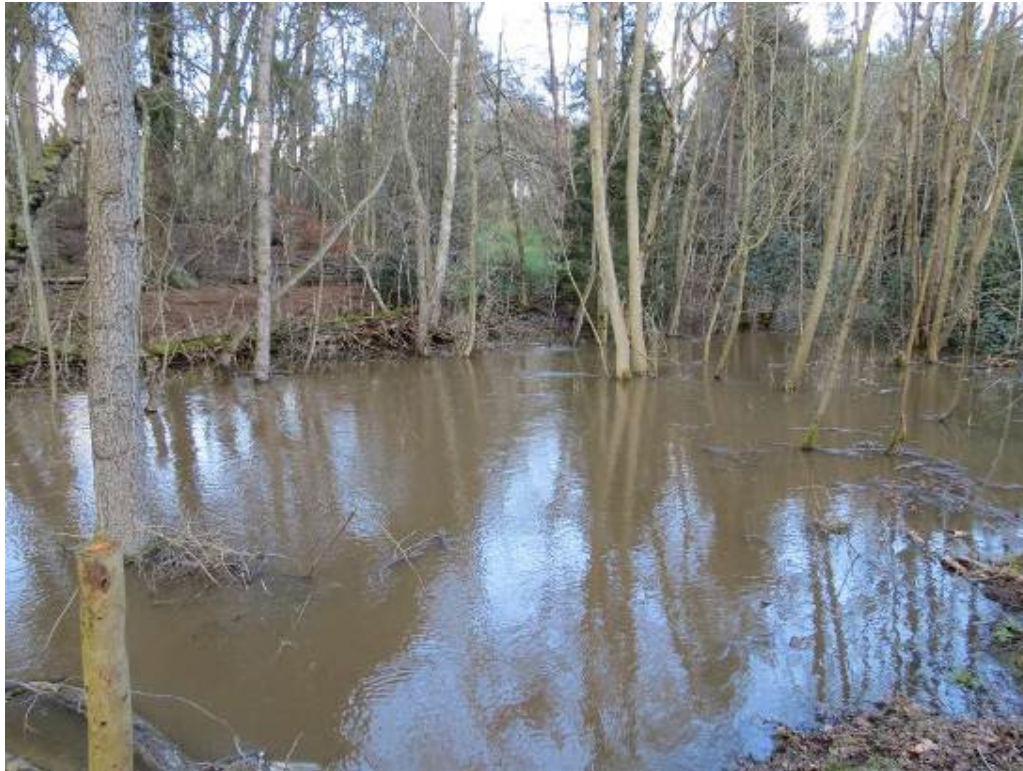
Backing-up of water upstream of LWD dam during flood

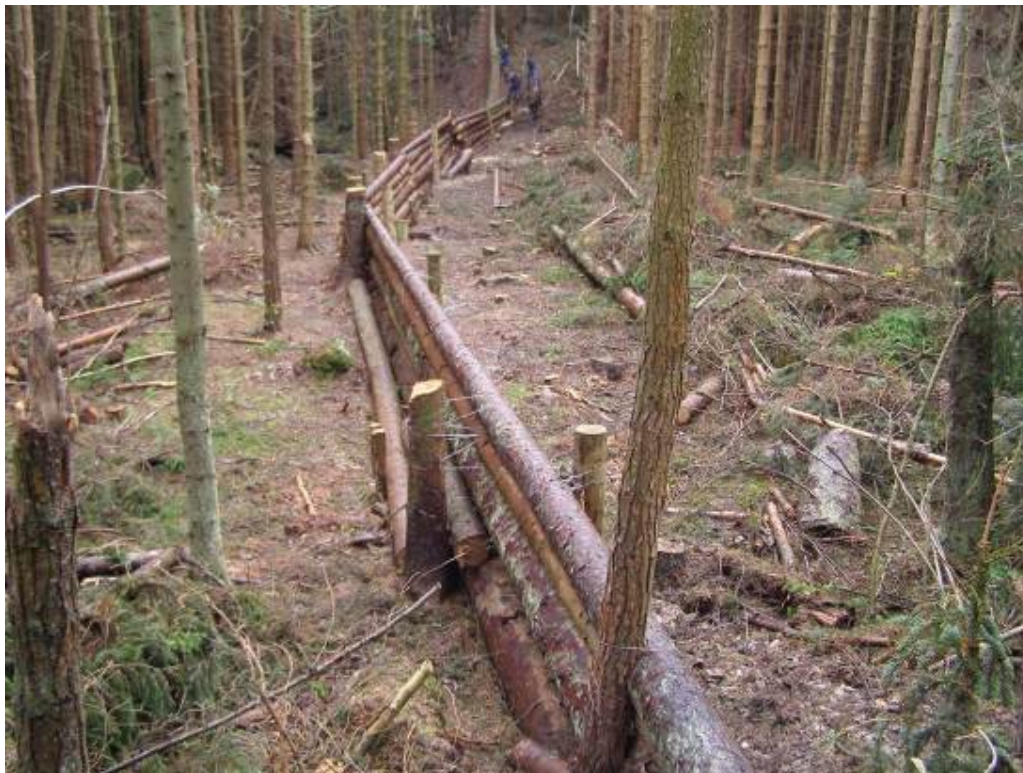
Upstream timber bund on Sutherland Beck

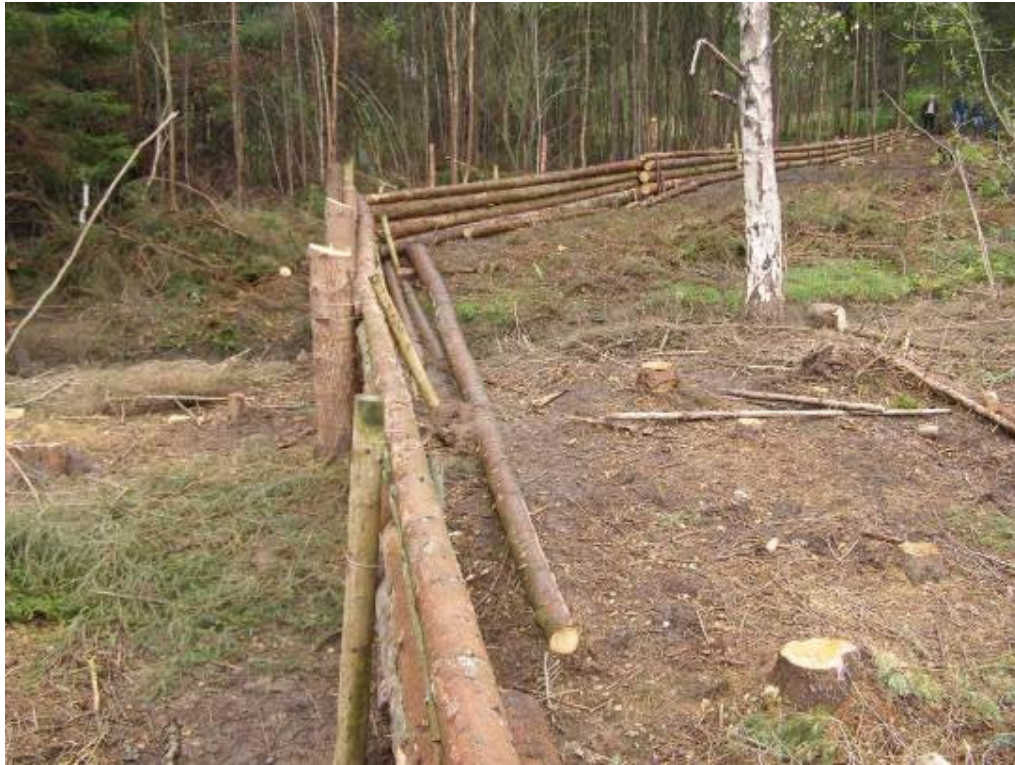
Downstream timber bund on Sutherland Beck

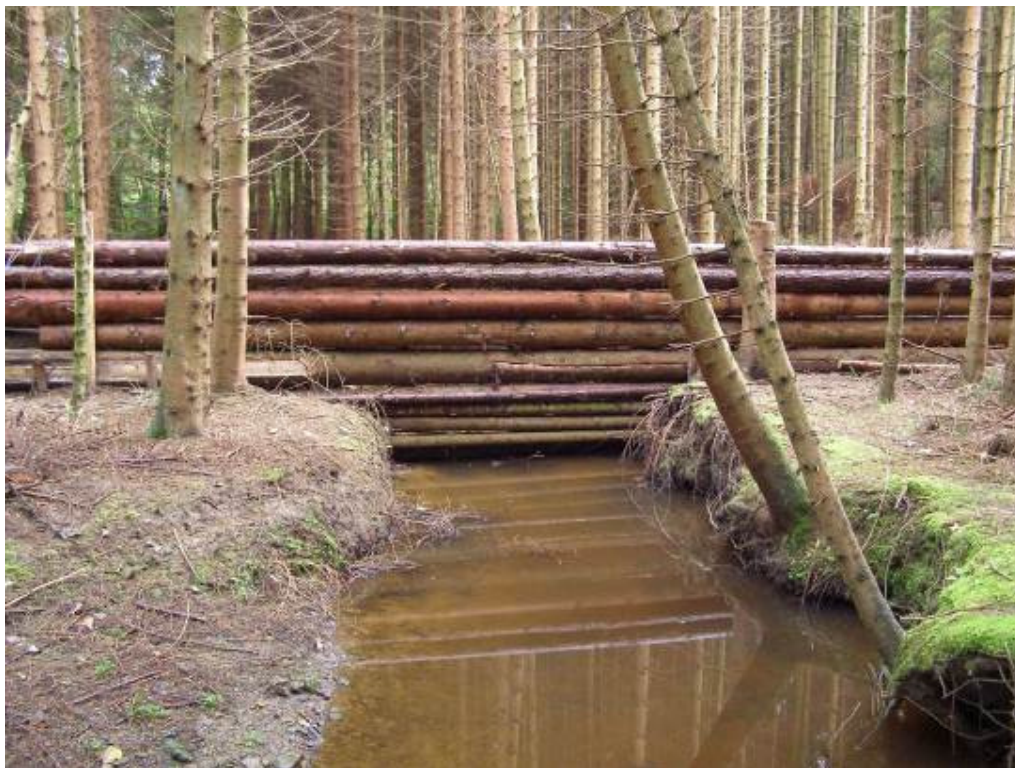
Face of upstream timber bund

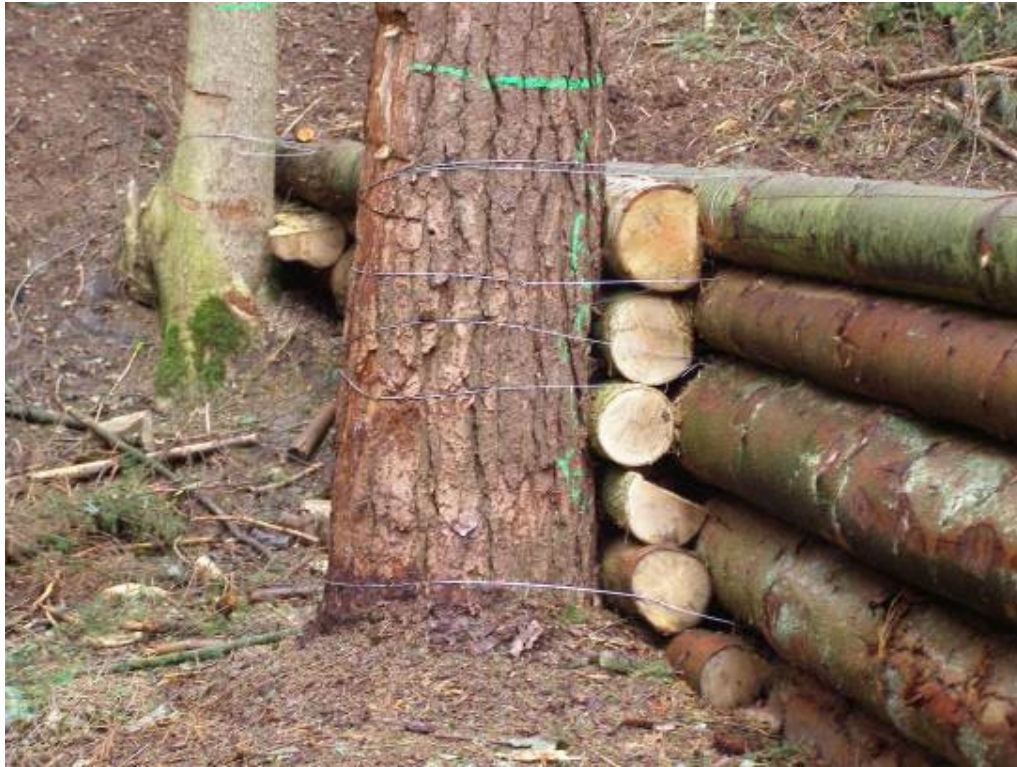
Use of wire to secure timber bund to long tree stumps

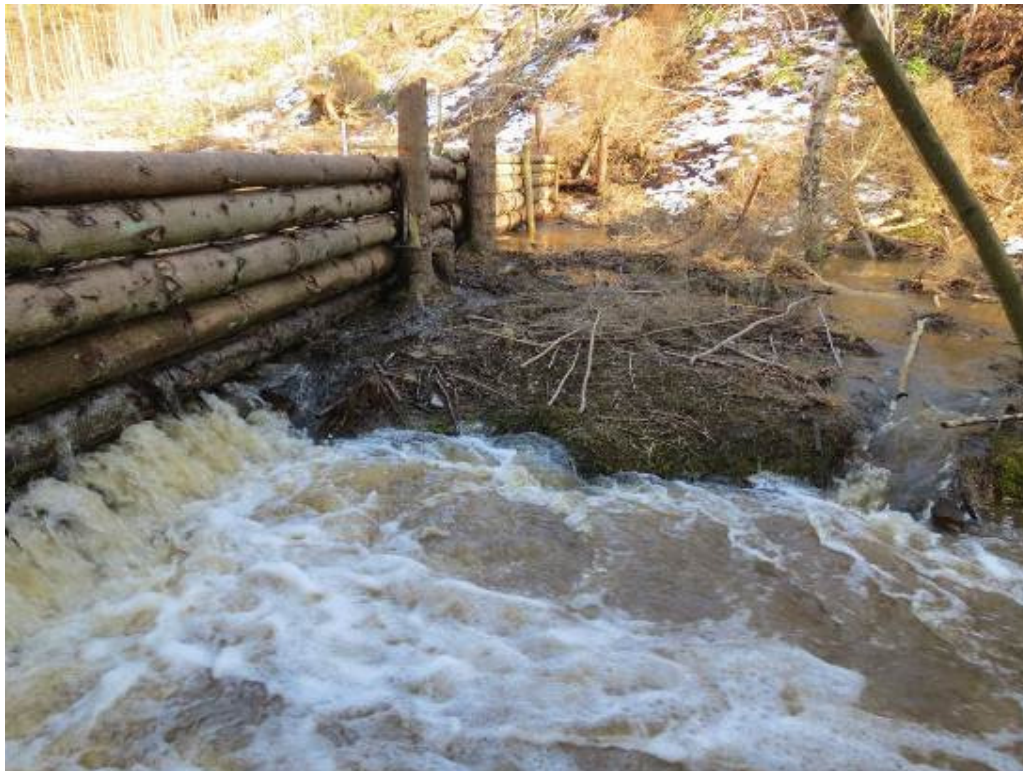
Timber bund during high flows

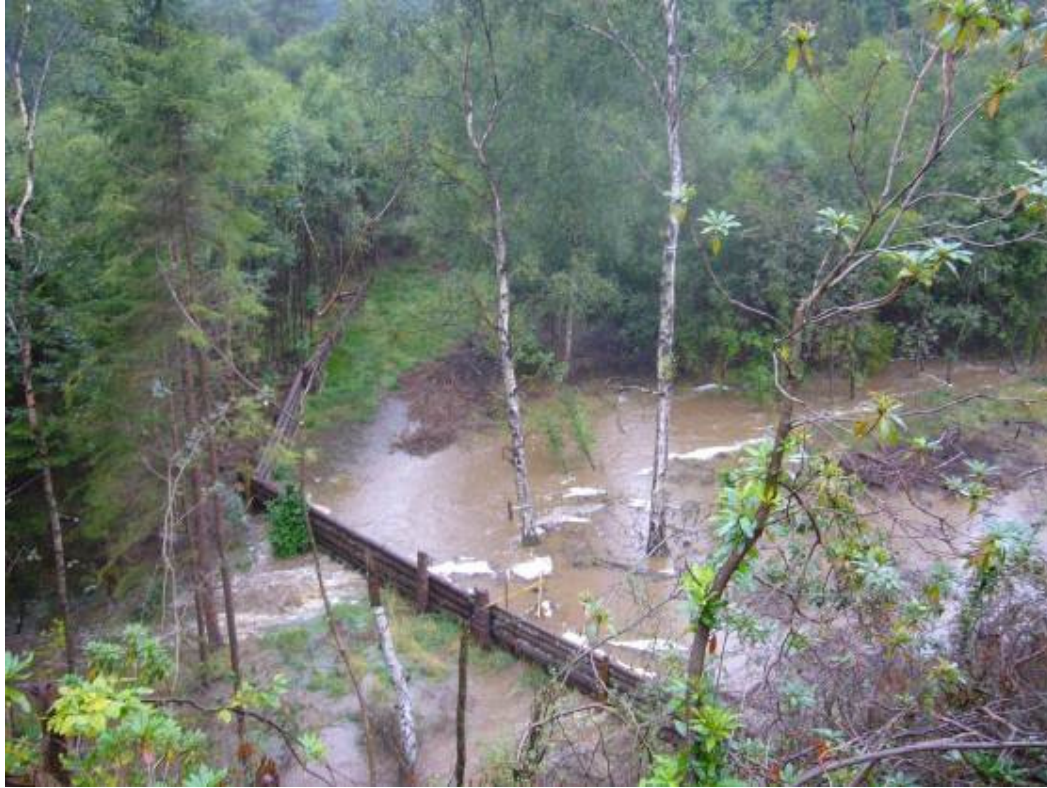
Downstream timber bund during November 2012 flood event (out-of-bank flow but water level only at first log in bund)
