Greenoakhill landfill site, reclamation monitoring

Summary

Introduction

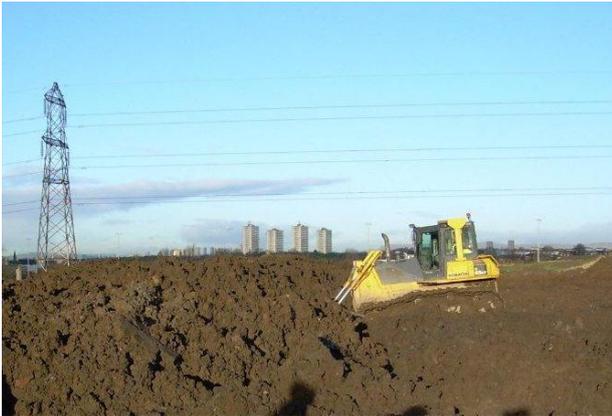
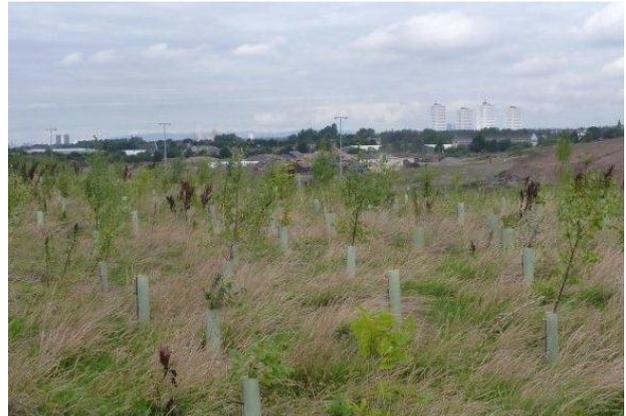
South west tip December 2006

August 2013, after three seasons' growth

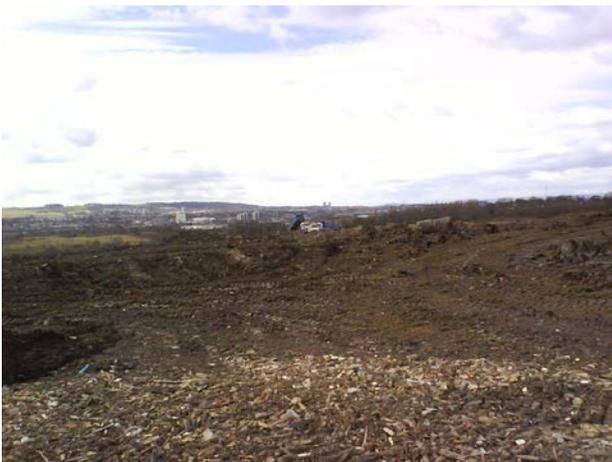
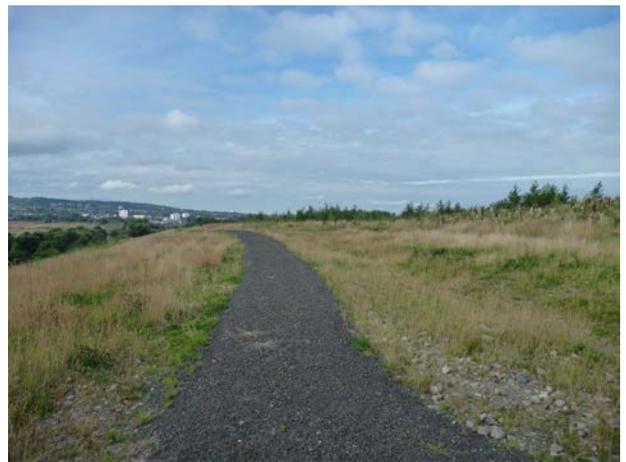
South west tip March 2008

August 2013, after three seasons' growth

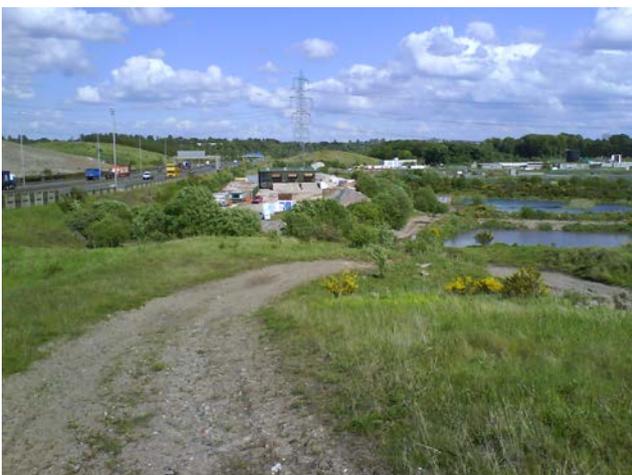
Figure 2. Southern section from south-west tip, with south-east tip beyond the pylon

The southern section of the landfill site is accessed from the north by a motorway underpass. This was only used for commercial / industrial waste, including large quantities of inert geological deposits from construction site excavations. The waste was deposited in a larger tip to the south west (completed in 2010) and a smaller one in the south east, which was largely completed before 2006 but had additional grading in 2008. The latter was seeded and partly planted with broadleaves in the west before 2006, although growth was poor owing to compaction and poor nutrient status. The gross area of the site to be reclaimed was c 11 ha, with approximately half requiring cultivation with compost to enable tree planting

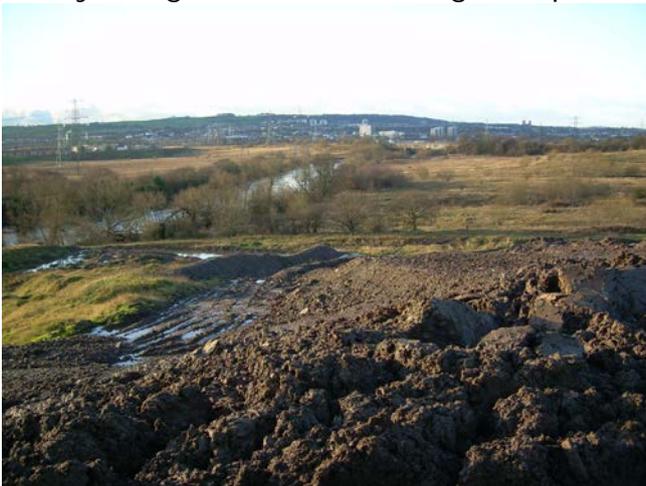
Figure 4. South-west tip, December 2006

Both the south-west and south-east tips comprised inert, inorganic, non-putrescible waste of commercial / industrial origin that had been laid down over many years, initially filling former sand and gravel pits, which were then surcharged as levels rose.

The tipped materials were visually characterised as subsoils and geological drift from civil engineering sites, broken concrete, rocks, blocks and brickwork together with associated steel reinforcing and miscellaneous obstructions. Drift and soil forming material formed the majority of materials by bulk, and these generally had a high clay composition and varying stone content.

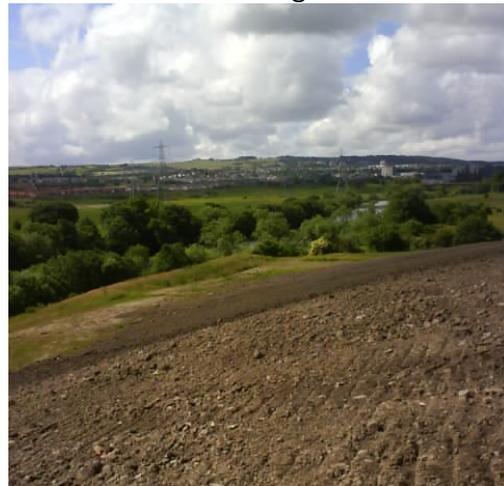
Figure 5. South-west tip, June 2008

Landfill site practice was to prepare for final restoration in the months prior to completion of the tip. This was described as setting aside imported loads of the 'better' soil forming materials for subsequent use as final surface. When observed, this practice appeared to be reliant on the judgement of incoming lorry drivers and supervisors.

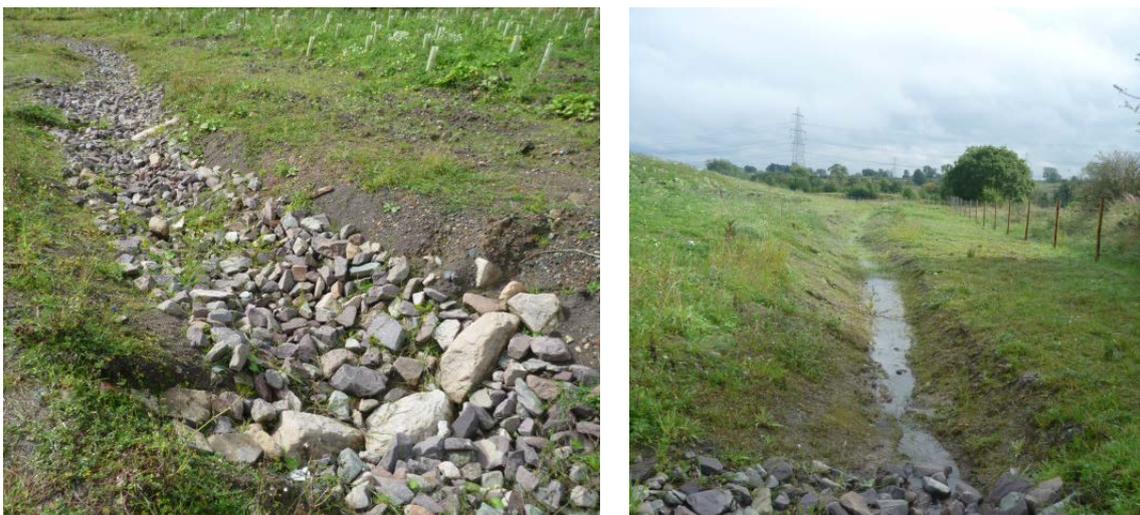
Figure 11. South-west tip, armoured drain with sill (left) and merging into swale on west boundary (right) on 9/9/11

Stone armoured drains: a detailed specification was provided for 'minor stone armoured channels' for steeper slopes above the maximum allowed for earth drains (3.5% or 2°) and up to c 15% in the East (**Figure 11**).

The specification required that stone 'sills' were formed every 10 m along the drain and this was a key parameter required by the Forester. The sills comprised stone blocks (nominally 50 cm long * 25 cm * 45 cm) set by hand into 25 cm * 25 cm trenches cut across the drain profile prior to laying the geo-textile so as to accept the blocks in a form of transverse 'weir' stabilising the intervening stone armouring. The intention was that following armouring the sills would not protrude.

The rock for the sills of the **stone armoured channels** was required to meet specification and, as this was not able to be met on site, it was sourced from a commercial hard rock quarry at Croy, Kilsyth at some expense. Although the appearance of sills could have been improved, and some of the loose stone fill at the edge of trenches was undersized, the result was functional.

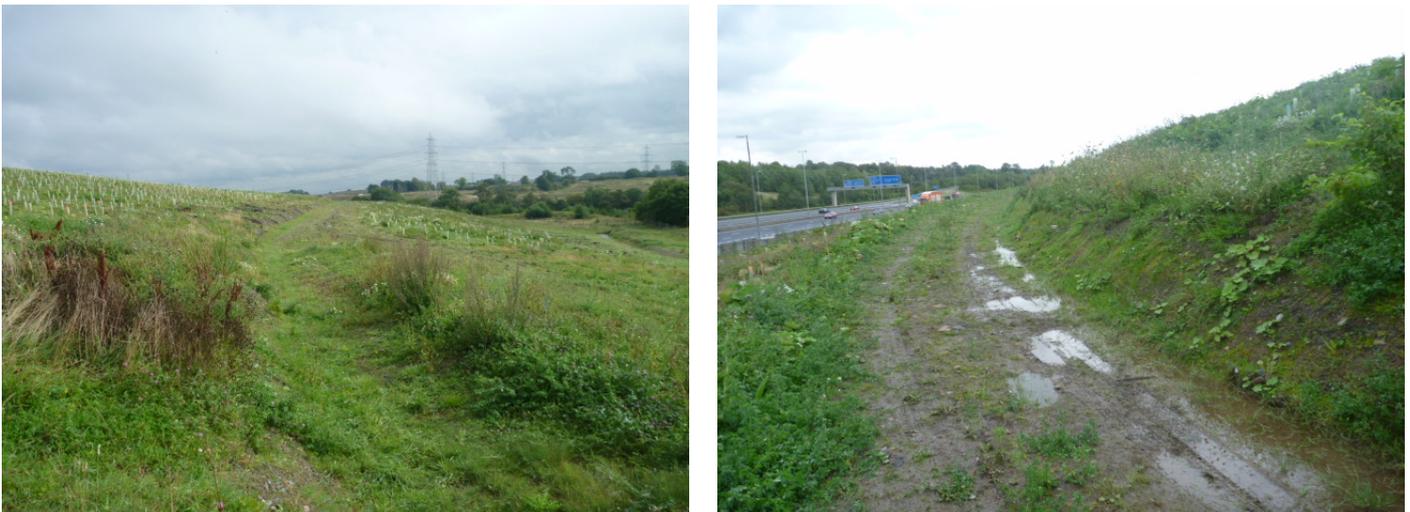
Figure 13. South-west tip, lower berm (left) and south-east tip north face prior to path installation (right) on 9/9/11

Berms: constructed by excavator having the required 5-8% smooth 3 m wide cross-fall back into the slope and a consistent, even longitudinal gradient of 1¹/₂ - 2¹/₂% around the hill face according to the construction plans (Figure 12). Berms were made by excavator and were formed to feed seamlessly into drains (**Figure 13**). Consolidation was achieved by machine trafficking as berms were planned and used as the primary hard routes for movement of machines, drain spoil and compost etc.

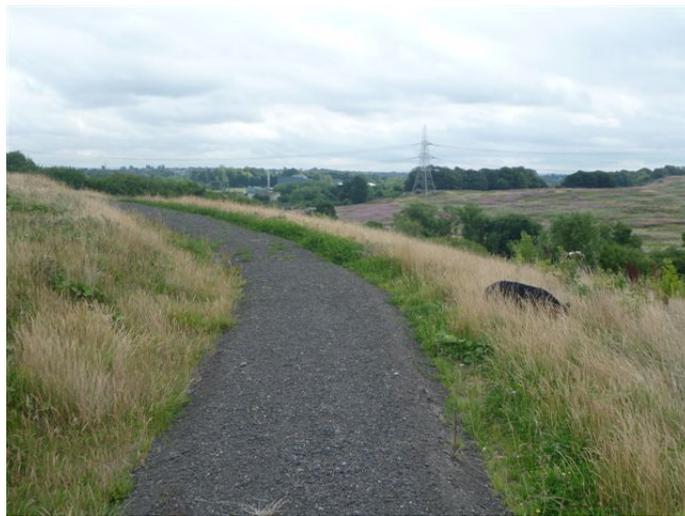
Figure 14. South-west tip, path on upper berm looking south-east 28/8/13

was according to a standard design onto the firm base provided by berms or graded but uncultivated ground. Other than those situated on berms (**Figure 14**), the path route was alongside existing swale drains. Both the formation and path surface had a cross-fall of 8% on the berms and a camber elsewhere. No geotextile was used but the surface 50 mm of the path formation was removed prior to laying the Type 1 in the resulting 'tray'. The specification was for 1.5 m surface width of two rolled layers: 100 mm Tarmac 'Toptreck' recycled chippings over 100 mm Type 1 aggregate. The recycled chippings were a mixture of asphalt and other recycled materials ground and screened. Culverts were installed where needed using 300 mm or 400 mm twin walled plastic pipe. The path edges were consolidated using a vibrating plate (or 'whacker').

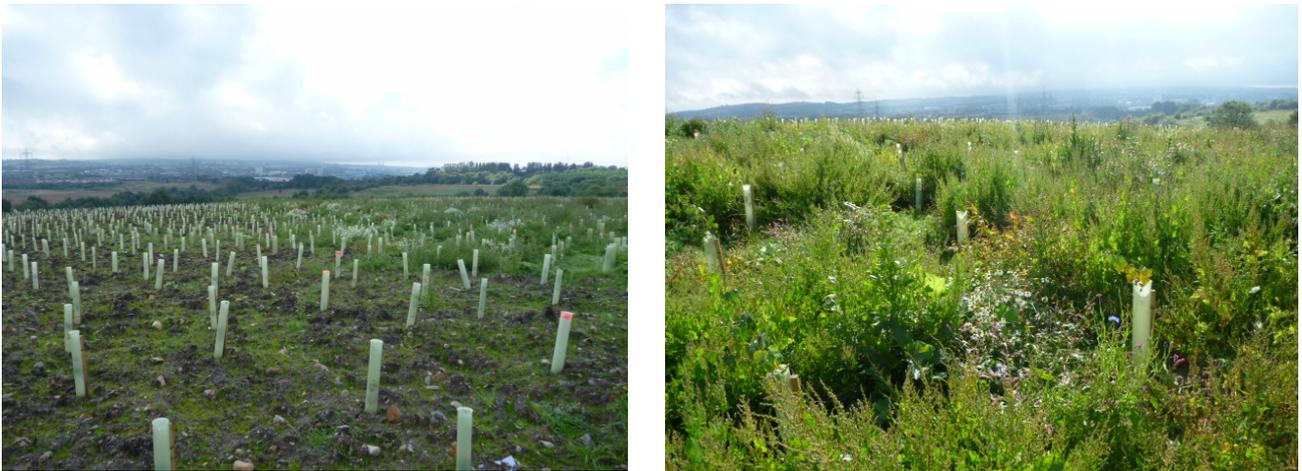
Figure 17. Variation in weed growth (cell W11, south-west tip) September 2011

Owing to variations in weed growth in 2011, largely related to the quality of the soil in individual cells (**Figure 17**), only about a half the area needed spraying and a similar area was strimmed - in July and August respectively.

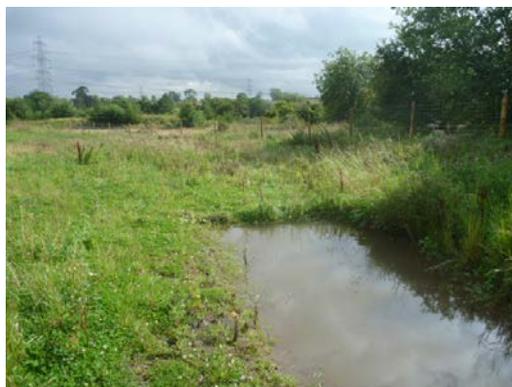
Figure 18. Silt trap and filter zone 9/9/11

Civil engineering: The swales, berms and armoured drains were effective at intersecting and leading surface water off the land without signs of erosion, both initially and after three seasons. All drains in excess of the earth drain continuous slope maximum of 3.5% (2°) were armoured. The west tip silt trap (**Figure 18**) was effective and well separated from the River Clyde by fully vegetated and gently sloping ground.

There were no issues of **silt** draining from the cultivation areas on the steeper slopes owing to excellent infiltration to the cultivated profile and also to the landform at the foot of slopes adjacent to sensitive areas in general. Drainage from the east of the south east tip was enhanced with a 1 m * 1 m * 2m long soak-away filled with stone and filtration zone at its end. Thus there was no direct connection into the deep roadside drain at this location, which has been prone to flooding in the past. This has proved very effective.

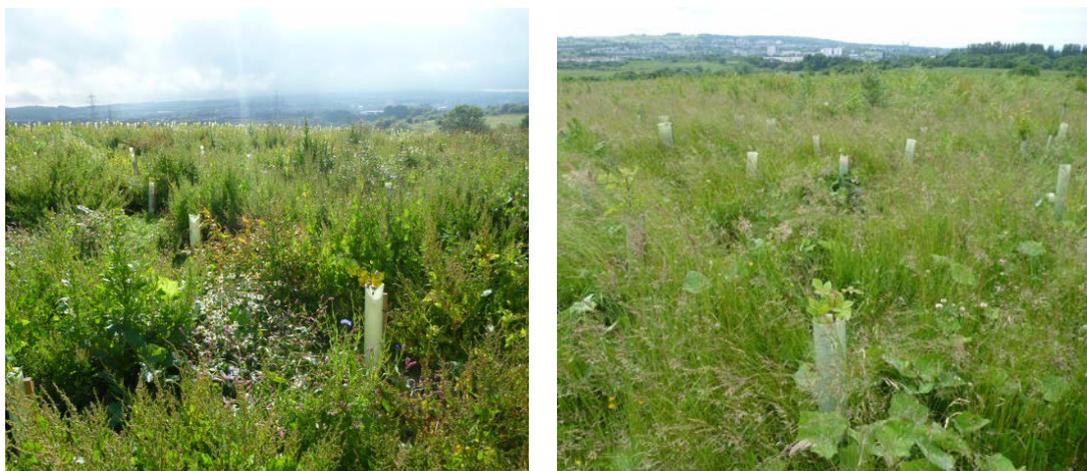
Figure 19. West tip, cell W11 on 9/9/11 (left) and 25/6/13 (right). Note change in type of ground vegetation from pioneer herbs to grass

Ground vegetation: As anticipated, there was significant weed growth in the first season, which comprised largely broadleaved annual herbs commonly occurring as agricultural weeds. Considerable variation over the site between cells but also within parts of cells were observed and assumed to be the result of variation in time of cultivation and potentially also soil quality tipped over discrete parts of the site. This was confirmed by the Forester, for example in respect of cell W11 on the west tip which displayed two quite distinct vegetation growth characteristics although the ground was cultivated at the same time. Growth was noticeably less in the southern half where the soil was more cohesive and clayey than to the north of the same cell.

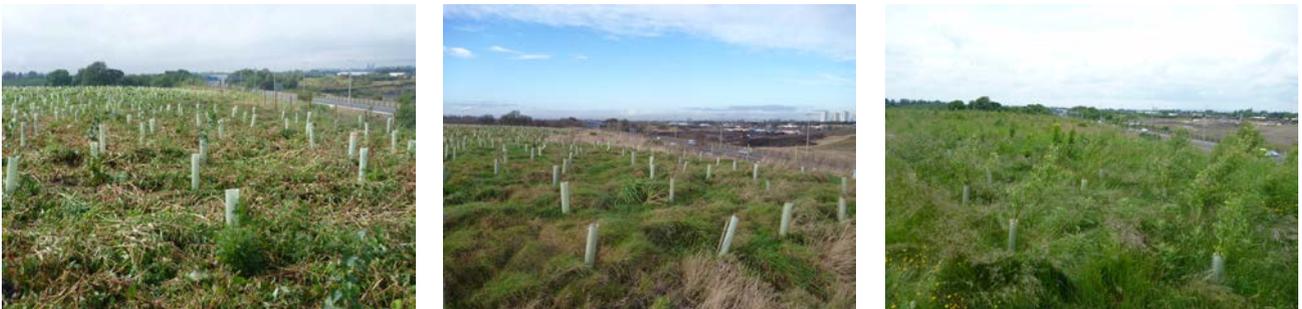
Figure 20. South-west tip, cell W13 on 9/9/11 after strimming (left), 21/11/12 and 25/6/13 (right)

The robust plant and protection specification used at Greenoakhill was justified by the strong initial weed growth that had been forecast as a result of research trial experience on the site. This included the use of cells grown seedlings as compared to bare root transplants and 60 cm tree tubes with two ties per tube. Blocks were trimmed and / or chemically spot weeded so that weed growth was not able to 'swamp' tubes, which FR experience in Central Scotland has shown can happen rapidly in the first season. As would be expected, there was a succession of ground vegetation over time (**Figure 20**).

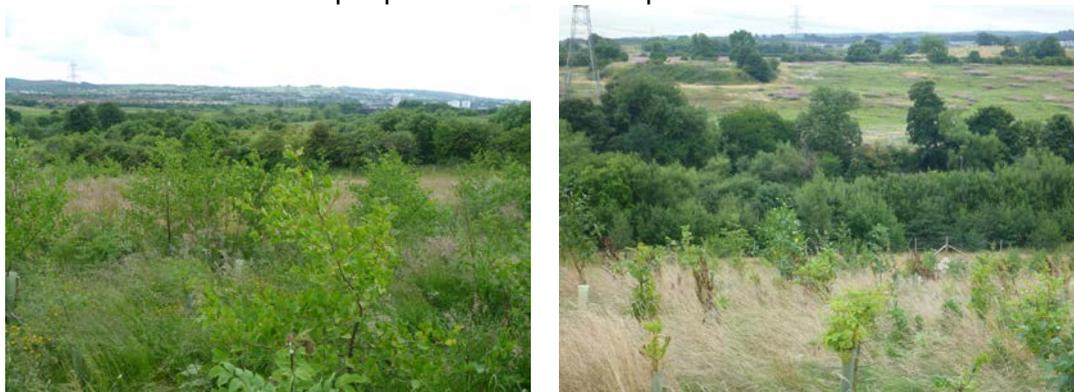
Figure 21. South-west tip, cell W5-6 on 25/6/13 (left) and cell W3-4 on 28/8/13

Tree performance: Survival, early tree growth was generally good across all species. Fast growth of ash, alder, birch, field maple and larch was particularly evident, with some birch and a few ash exceeding the 60 cm tube height by July of the first year (**Figure 21**). By the end of the first season (2011) many trees were well above the 60 cm rims. Growth of the taller species had attained 1.2 - 1.5 m with an average of c 60 cm by the end of the second season. The slower growth of species such as oak was considered normal and proportionate in comparison.

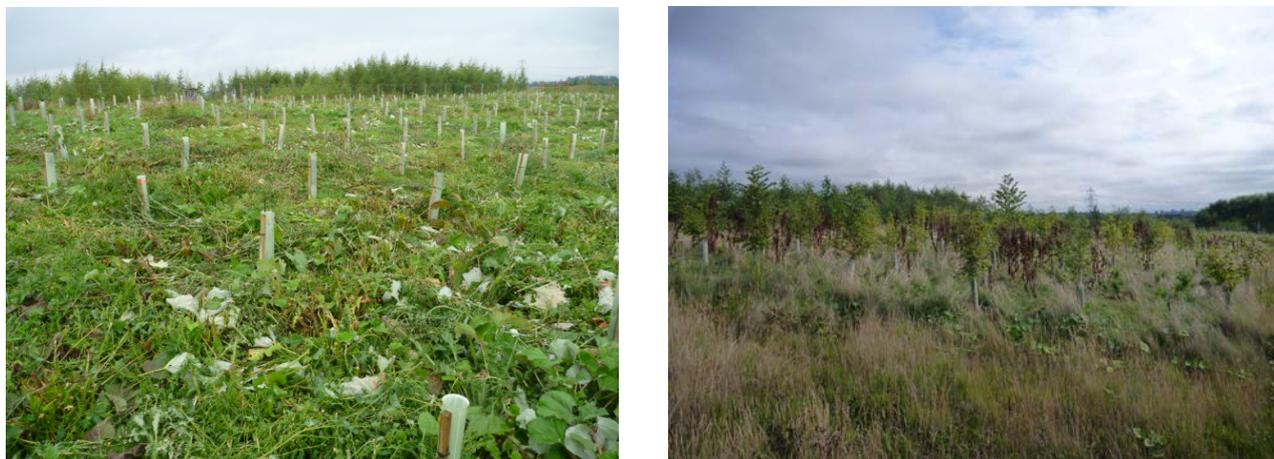
Figure 22. South-west tip, cell W14 on 9/9/11 after strimming (right) and showing leaf yellowing on 28/8/13

By June of the third season (2013) some areas of faster growing ash and birch on the south west tip and ash on the ridge of the south east tip were observed to have foliage yellowing, which also affected other species to a greater or lesser extent and was patchy within blocks (**Figure 22**). This was investigated by foliage sampling, described in the section below.

The foliage sampling results indicate that **the yellowing of ash and birch foliage is due to nitrogen deficiency**. There was also a tendency towards lower phosphorus and potassium levels in birch, although not deficient. Comparison with the post reclamation soil sampling results (**Table 9**) appear to show a correlation of yellowing in block 14 with lower total soil nitrogen, although insufficient samples were available to confirm this.

The occurrence of nitrogen deficiency symptoms in some areas of faster growing species in season three is not in itself considered to be a concern. This is because the area overall area affected was relatively small (approximately <10 - 15%) and the trees were still growing satisfactorily. Furthermore, nitrogen levels are expected to rise as woody matter in compost gradually mineralises, releasing available nitrogen. In the longer term, nutrient recycling and general development of a healthy soil ecosystem will also improve conditions, although tree health should continue to be monitored.

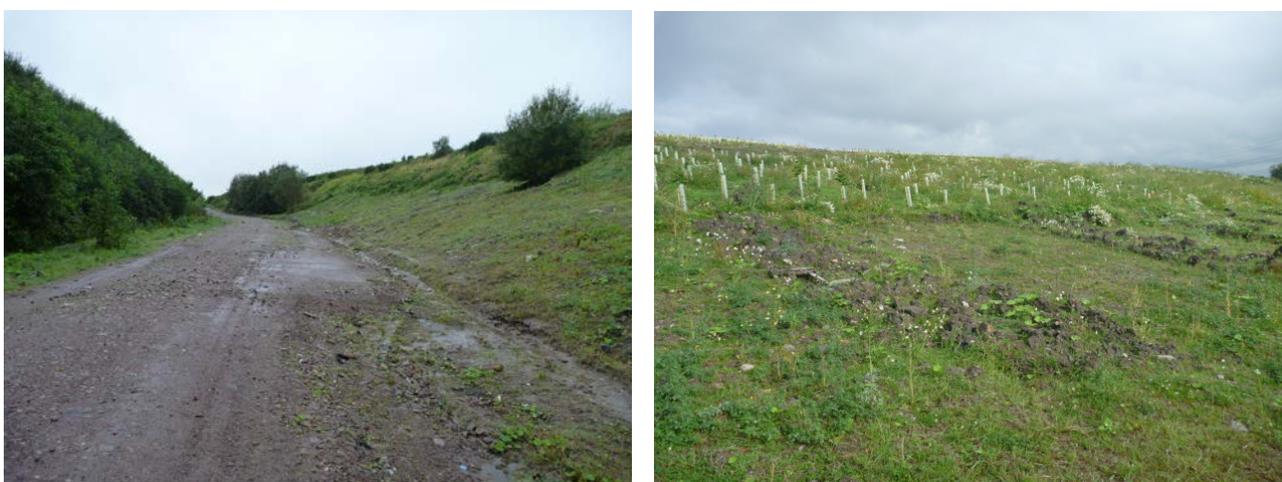
Figure 23. West tip on 9/9/11: Access road (left) and cell W5-6 drainage taps (right)

Summary
12 July 2011. Post restoration & soil sampling (Photos)
<p>Soil - loose growing medium created by cultivation to c 100 cm and mixing with compost to c 50 cm (cell W10 = c 40 cm)</p> <p>Vegetation cover - 10 - 50% but occasionally more, mostly broadleaved weeds with generally very little grass growth, probably from seed</p> <p>Trees - survival generally good (>80-90%). Birch growing best. Oak small with limited growth but other species intermediate. Most trees not at 60 cm yet, except some Birch and fewer Ash.</p> <p>Engineering - effective system of drainage taps, berms and drains (including armoured drains)</p>
9 September 2011. Late season 1
<p>Vegetation cover - strong growth of broadleaved agricultural weeds, but not smothering trees yet. Recent strimming of most weedy blocks and evidence of spot chemical weeding in places. Occasional areas of fairly dense sown-grass helping to displace weeds and ryegrass growing on some 'open' spaces</p> <p>Trees - Overall good survival, many now growing above rim of 60 cm tubes e.g. AH, Bi, AR & some ROW & SOK, variation in growth between blocks</p> <p>Engineering - drainage system functioning well, cell drainage evident from drainage 'taps' (Figure 23).</p>

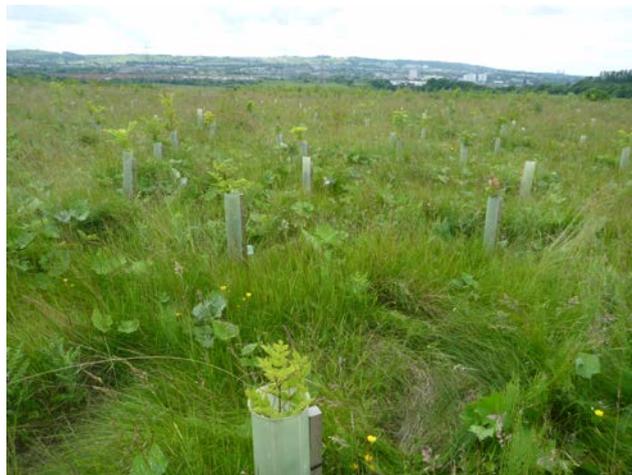
Figure 24. Yellowing of ash on part of the south-west tip in June 2013

The **symptoms** were that some patches of broadleaves showed foliage yellowing, especially in ash and silver birch and other species including rowan in the south west (**Figure 24**). Yellowing appeared more pronounced in faster growing species although alder, which has nitrogen fixing capabilities, was always green and healthy. The areas most obviously affected were in blocks W11 and W14 in the north of the western tip, and tree growth appeared marginally less in ash and birch, but not in larch. The variability between areas within the blocks was suggestive of compost / soil forming material mix variation. This was confirmed by the Forester, who advised that compost mixing in the southern part of W11 had been less effective owing to the highly cohesive (clayey) nature of the soil, and that cell W14 was the last to be completed and so the compost mixing might have been less effective. Similar symptoms were observed in ash on the ridge of the south east tip.
