Assessing the Decay and Integrity of Timber Structures used for Natural Flood Management on Sutherland Beck, Pickering, North Yorkshire

Huw Thomas & Tom Nisbet
Forest Research
April 2020

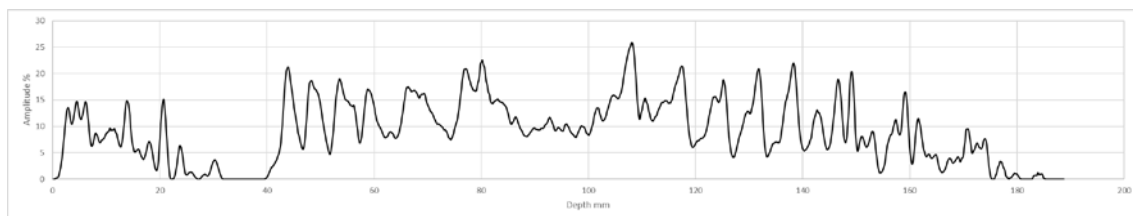
An example of the output from the microdrill is given in Figure 2, which shows the set of drill readings from a single drill point, indicating an area of decay at between 22 mm and 40 mm depth. The device returns high resolution data, with a reading taken every 0.1 mm depth. The full diameter of each log was drilled.

Figure 2 Output from the microdrill showing distinct areas of potential timber decay between 22 mm and 40 mm depth in the sampled log
