# Soil status assessment of legacy forest reclamation sites: Case studies

Reclamation Sites: Optimising organic amendments for tree growth in Central Scotland  
*FC Scotland contract 438*

Operational guidance for the use of quality compost in forestry management  
*WRAP contract OMK004-021*

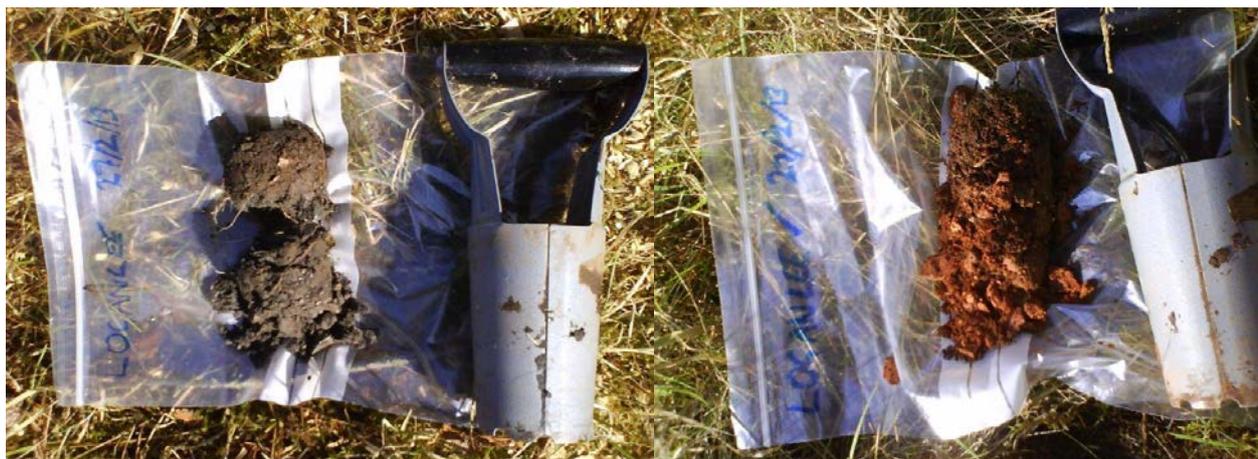
A **soil sample** was collected at each scoping survey point location using a steel core tool (**Plates 9 to 16**). This was capable of collecting a cylinder of humus and mineral 'soil' of known volume that, together with the sample fresh weight, enabled calculation of approximate *in situ* bulk density. The soil sample represented the entire likely rooting depth, which was usually to the barrier formed by an underlying hard, compacted SFM layer at a generally shallow depth which depended on the site.

**Plate 9.** Fauldhouse core (Note <sup>6</sup>)

**Plate 10.** Loganlea core

<sup>6</sup> Scaling, Plates 8 – 13: Bag is 22.5 cm \* 35 cm. Tool cylinder is 12 cm deep (apertures - top 7.5 cm, bottom 6 cm)

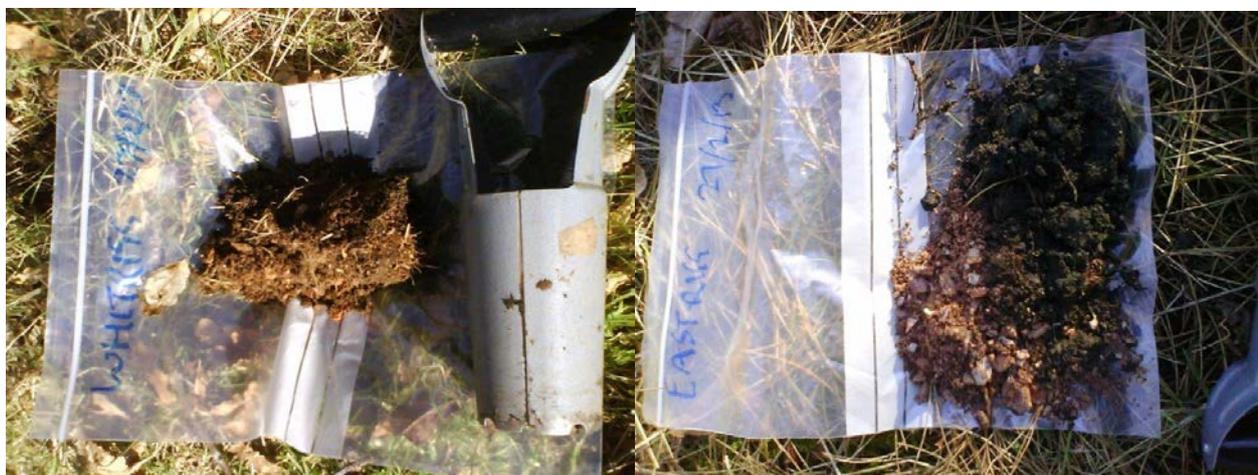
**Plate 11.** Whitrigg core

**Plate 12.** Easton core

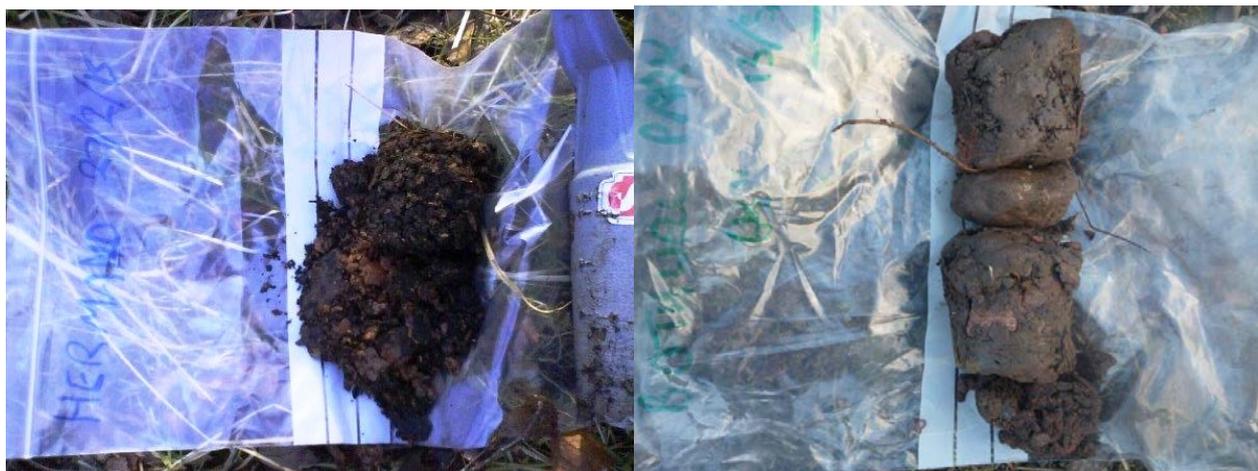
**Plate 13.** Hermand core

**Plate 14.** Bothwell core

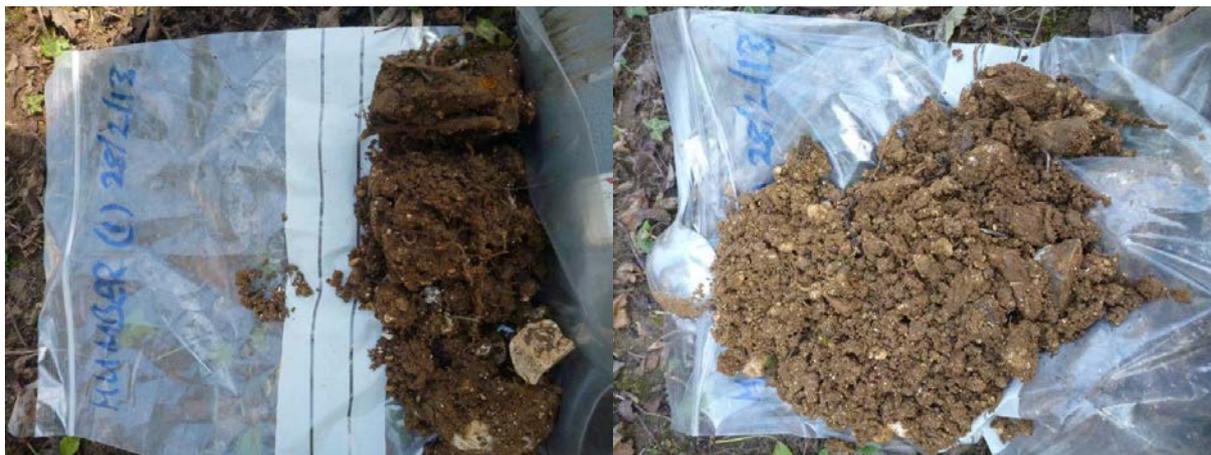
Plate 15. Ferriby core - upper

Plate 16. Ferriby core - lower

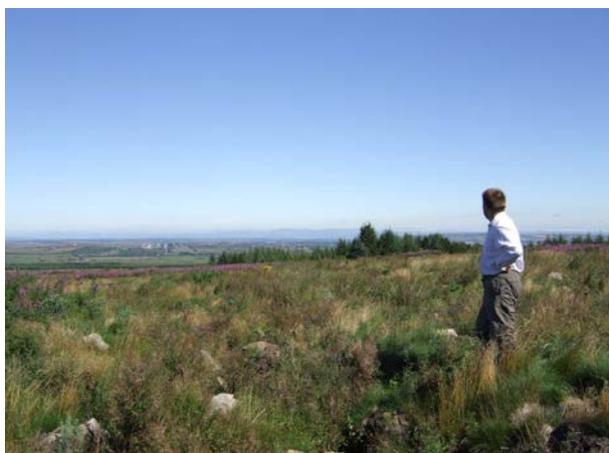
The physical character of the Soil Forming Material below the present rooting zone is **supplementary information** because it is relevant to any proposed reclamation specification. Similarly, the ground vegetation at the sample location is supplementary because it may be influenced by a wide range of factors including canopy. Vigorous, diverse vegetation on a loose, well-drained surface is a 'good' sign (**Plate 17**) and sparse, limited, checked vegetation on clearly compacted ground is 'bad' (**Plate 18**).

Plate 17. Woodmuir former colliery 2/8/06  
Complete cultivation with biosolids

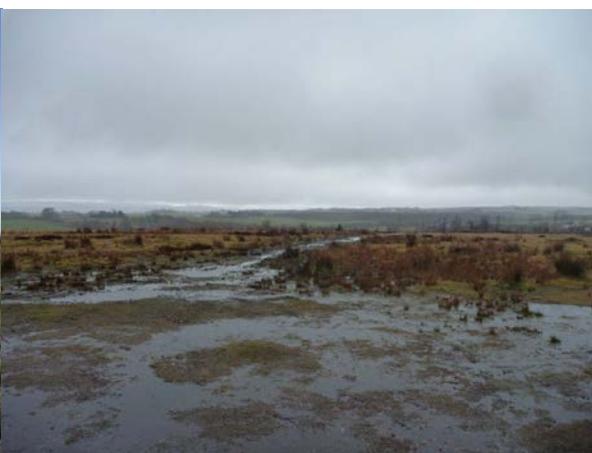
Plate 18. Whitrigg former colliery 14/3/11  
Graded but uncultivated spoil bing

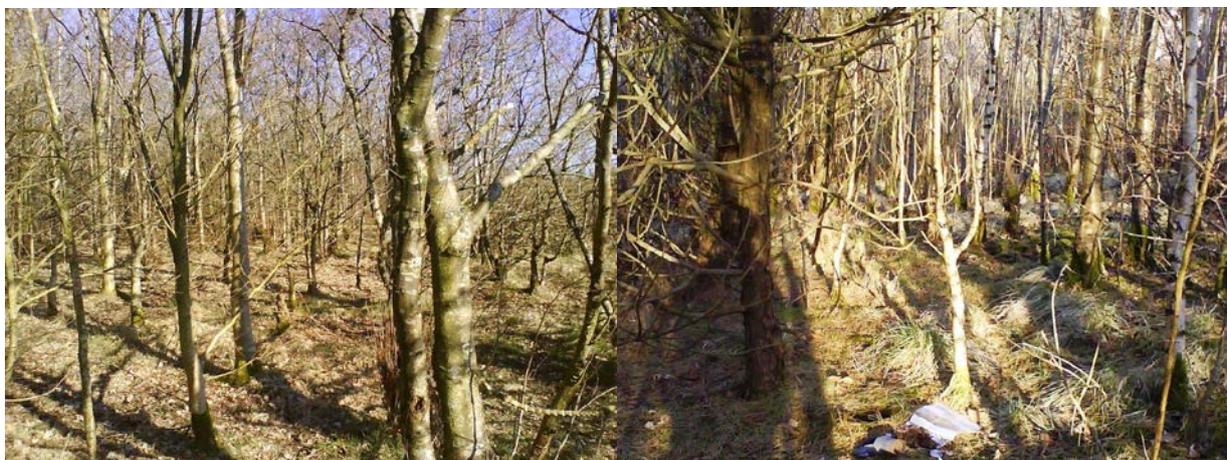
The results of the scoping survey suggest that **all the sites are capable of growing apparently healthy woodland** in a very shallow surface soil (**Plates 19 and 20**).

Plate 19. Whittrigg core location

Plate 20. Easton core location

However, **all sites had poor root-able depth** with six of the seven sites having 15 cm or less, including an often significant humus layer, although structural roots may have grown deeper in any rip lines present.

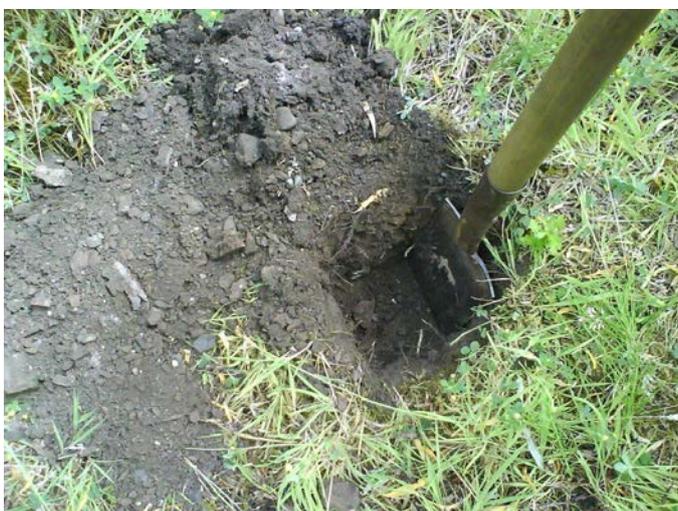
A simple visual and trowel based assessment will indicate the physical nature of the material (**Plate 21**) that would need to be cultivated to improve the rooting zone, especially its compaction, stone and clay content and organic matter status. The depth to a very compacted or very waterlogged layer indicates the present potential rooting depth and hence the amount of material that needs to be improved to increase the rooting depth to the 100 cm or more regarded as ideal for most tree species.

**Plate 21.** Halside former steelworks – shallow, stony but moderately vigorous ground cover
